## Lessons Learned from Missing Flooding Barriers Operating Experience

Zdenko Šimić and Miguel Peinador Veira

European Commission Joint Research Centre

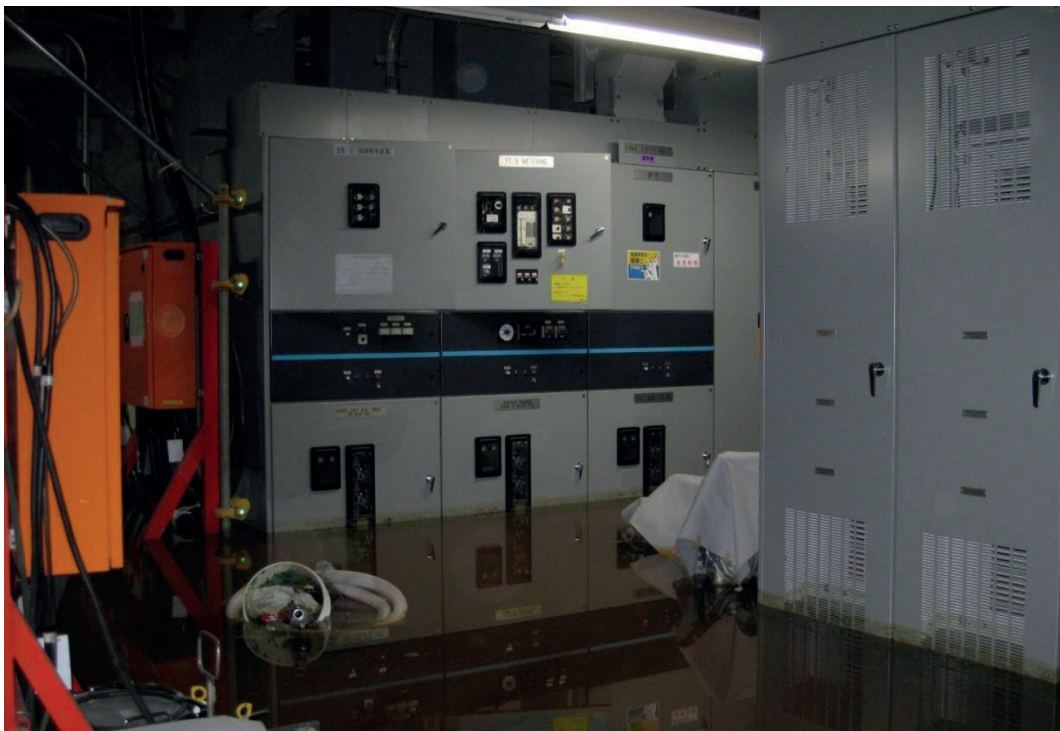
Figure 1 Example of Flood in Electric Equipment Room of Unit 6, pictured on 03.17.2011.  
(Source: TEPCO [photo.tepco.co.jp/en/date/2011/201108-e/110810-01e.html](http://photo.tepco.co.jp/en/date/2011/201108-e/110810-01e.html))

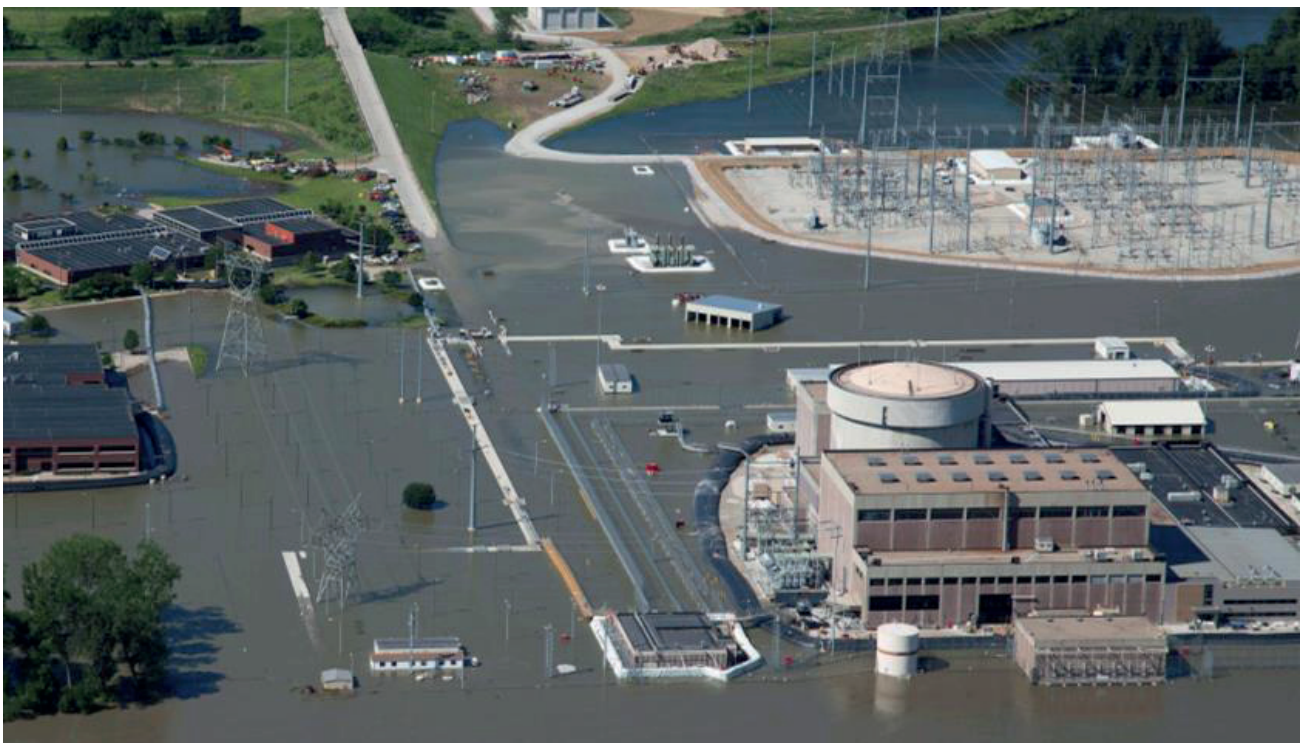
**E14 Fort Calhoun Station, NRC identified inability to protect the intake structure and auxiliary building during external flooding.** Demonstration in Sep 2009, revealed that sandbags could not retain 1.5 m static head of water. Licensee failed to implement appropriate corrective actions based on new flooding information. Licensee's ECR revealed unsealed penetrations below the licensing basis flood elevation that could cause intake structure vulnerability during external flood. Corrective actions were: redesign and installation of flood protection features without need for sandbags; sealing affected penetrations; revising procedures. This is yellow<sup>3</sup> finding from NRC IR, [6].e. Even this is finding before Fukushima accident it is still included because it demonstrates appropriate preventive inspection regarding later licensee's findings and later demonstrated capability to withstand major external flood on June 6, 2011, Figure 2. Licensee's findings include unsealed penetrations through outside wall of the auxiliary and chemistry and radiation protection buildings (below the DBF elevation); unsealed conduits, 2 leading to the auxiliary feedwater pumps and 1 leading to safety related electrical switchgear; drain path from chemistry and radiation protection room to ECCS pumps rom; weak flood protection strategy for raw water pumps. Root causes include: weak procedure revision process; insufficient oversight of work activities; ineffective identification, evaluation and resolution of external flooding protection performance deficiencies; and related "safe as is" mind-set, [6].f.

Figure 2 Fort Calhoun plant on 16.06.2011 during the Missouri River Floods; vital buildings were protected using water-filled perimeter "flood berms" (Source: OPPD Public pres., 04.04.2012)

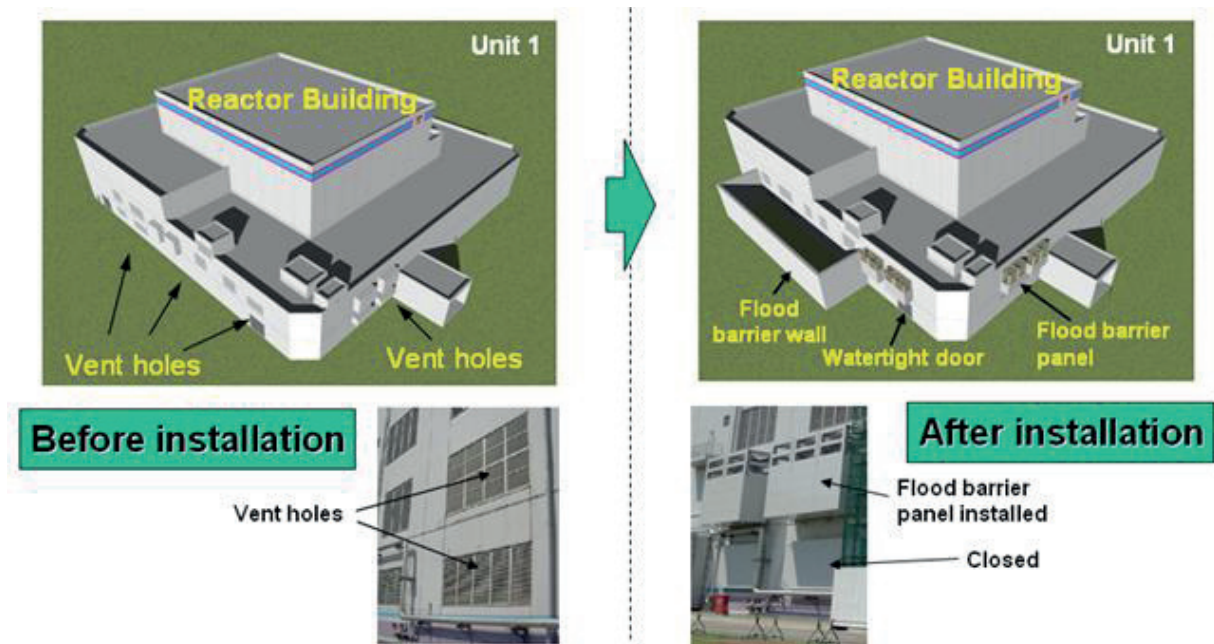
Figure 3 Example of measures to prevent flooding of the building: Kashiwazaki-Kariwa NPS. (Source: TEPCO [www.tepco.co.jp/en/nu/kk-np/safety/flood-e.html](http://www.tepco.co.jp/en/nu/kk-np/safety/flood-e.html))

Here proposed actions have potential to address all identified problems and help prevent specific consequences. However, flooding protection presents continuous challenge because even after all legacy issues are resolved there is need to continuously take care of aging, wear out and modifications related problems. In search for improvements EPRI has recently initiated a project to develop maintenance recommendations associated with flood seals with plan to publish them in the flood protection systems guide, [10.]. Therefore periodic maintenance and review are essential. Figure 3 and Figure 4 are illustrating some measures taken after Fukushima inspired review.

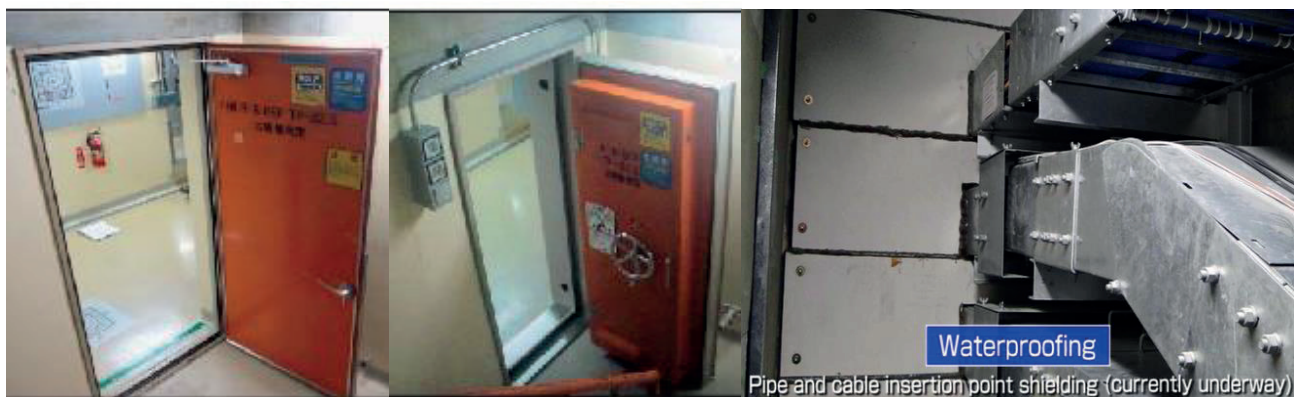
Figure 4 Example of measures to prevent flooding of the critical equipment room and water tight cable conduits penetrations: Kashiwazaki-Kariwa NPS. (Source: TEPCO [www.tepco.co.jp/en/nu/kk-np/safety/flood-e.html](http://www.tepco.co.jp/en/nu/kk-np/safety/flood-e.html), [tepco.webcdn.stream.ne.jp/.../201404-e.wmv](http://tepco.webcdn.stream.ne.jp/.../201404-e.wmv))
