## Possible accident scenarios related to the Spent Fuel Pool operating events

**Miodrag Stručić**

### ABSTRACT

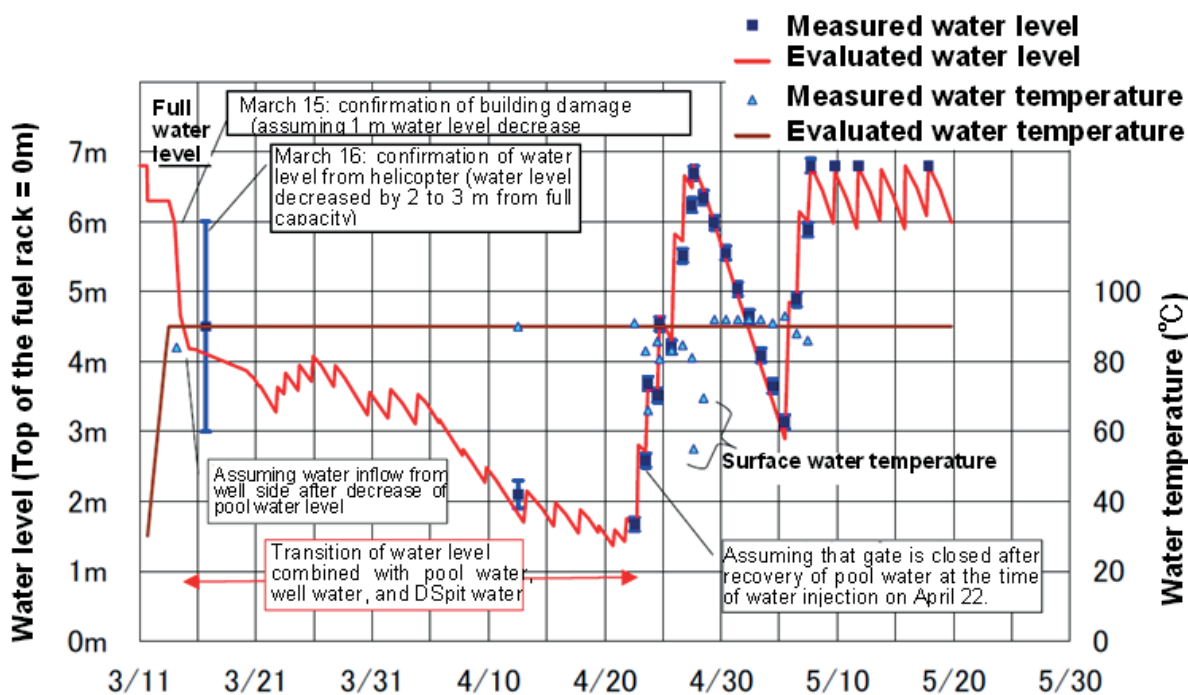
Figure 3. Evaluated water level and water temperature in the SFP 4 by TEPCO

According to the original schedule, the drain of the reactor vessel and reactor well should have been completed by 7 March 2011, but the operations were delayed and the reactor well was still filled with water on March 11 [4] [5]. This situation played an important role during the course of the accident and significantly slowed the decrease of the SFP 4 water level: the water-tightness of the pool gate was lost due to the pressure from the reactor well side as the SFP water level became low. It induced a water inflow from the reactor well to the pool.

At first, the water inflow from the reactor well was not considered and it was estimated that the fuel would be uncovered by late March. Therefore, from 20 March, water was added via helicopter, fire truck, and concrete pump truck. Eventually, the water level reduced to 1.5 m above the top of the fuel racks as the amount of evaporation was larger than the water injection, including water inflow from the reactor well, until around 20 April, as shown in Figure 3[3].

- The water level is assumed to have been reduced by 1.5 m as a result of sloshing by the earthquake and the explosion.
- Inflow from the reactor well occurred before 22 April. The water level was calculated by considering the water in the pool and the reactor well and dryer and separator pit collectively. After 22 April, the pool gate was closed, and no inflow from the reactor well was considered.

Later, intensive water injection conducted between 22 and 27 April succeeded in recovering the water level to the full capacity. The water injection was then suspended until 5 May to study the trend of the reducing water level. Subsequently, the water level recovered again to full capacity by intensive water injection, and then the water level is considered to be maintained at near full capacity by repeated reduction and recover due to evaporation and water injection.

On 31 July, pool water cooling by the alternative cooling system was started. The pool water temperature was around 75 °C when the cooling was started and reached a steady condition on 3 August when the water temperature stabilized at about 40 °C.

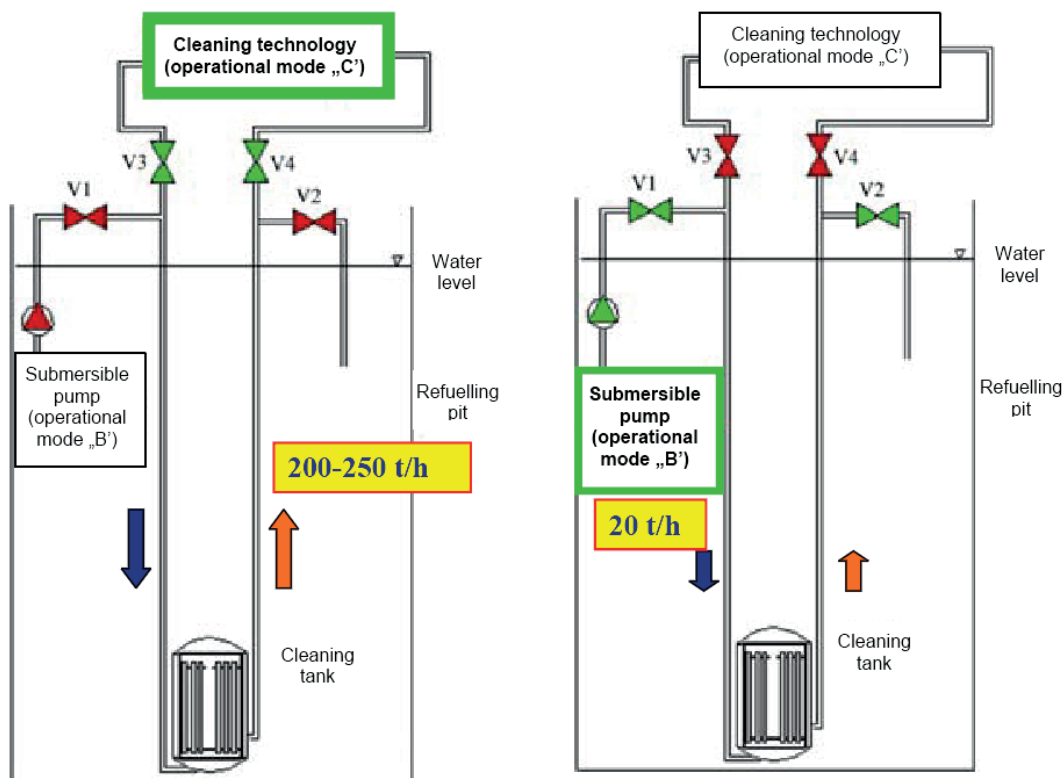
Figure 4: Arrangement of the cleaning tank cooling during cleaning (left) and post-cleaning (right) [7].

The cleaning programme for the sixth batch of FAs loaded into the cleaning tank was completed by 16:55 on April 10. The fuel was not removed from the cleaning tank immediately, since the crane was busy with other tasks. The coolant was circulated by a submersible pump with much lower mass flow rate than used in the cleaning process (Figure 4). Contracted specialists continuously maintained the cooling of the cleaning tank at 37 °C. At 21:53, activity was detected by the krypton measurement system installed in the cleaning circuit, and at the same time, the 'alarm' level was reached by the noble gas activity concentration monitors in the reactor hall, and then the operational dosimetry systems installed in the ventilation stack indicated abrupt increase of noble gas activity (max.  $0.2 \times 10^{13}$  Bq/10 min). The plant supervisor ordered to terminate the work carried out in the reactor building and to leave the area. An extraordinary maintenance committee was called, in order to evaluate the event and to take necessary actions. As highest priority, it was decided to open the cleaning tank, to carry out visual inspection, and if possible, to separate the nonhermetic FA and also to analyse the water quality.

Later inspection has revealed that, due to the special design of the cleaning tank and the characteristics of the fuel assemblies, the cooling by the submersible pump of lower mass flow was insufficient. The low flow rate pump was not capable of removing the decay heat (241 kW) due to a by-pass effect. The temperature stratification blocked the flow, and therefore, the coolant temperature reached saturation temperature in the upper part of the cleaning tank. Then, the steam-formation pushed the main volume of the coolant out of the cleaning tank vessel. This way, the FAs were left without proper cooling for hours and heated up to above 1000 °C, which resulted in severe damage and oxidation of the FAs. Oxidation in high temperature steam and hydrogen uptake resulted in embrittlement of the fuel assembly shrouds and the fuel rod cladding. When opening the cleaning tank, the injection of cold coolant caused the breaking up of the embrittled shrouds and fuel rod cladding.

Video examination indicated that most of the fuel assemblies suffered damage. Brittle failure and fragmentation of FAs were observed. Above the upper plate, several assembly heads were broken, standing in inclined position. One assembly header was found far from its original place. Many FAs were broken and fragmented also below the upper plate, and some assemblies were fractured in their entirety. Fuel rod fragments and shroud pieces accumulated on the lower plate between the FAs. Many fuel rod pieces and fragments of assembly shroud were dispersed within the tank. Some fuel pellets fell out of fuel rods, their form remained mainly intact. Heavy oxidation of the zirconium components was identified. Less oxidation was found in the periphery than in the centre, and the bottom part of the fuel remain intact. The radioactive noble gases that escaped from the damaged FAs were released into the environment through the reactor hall stack with negligible impact on the environment. Most of the non-gaseous fission products were trapped by the large water mass of the pool, and removed by the water purification system [9].

- the by-pass flow at low flow rate amounted to 75-90 % of the inlet flow rate, which led to the formation of a steam volume;
- the maximum temperature in the tank was between 1200 and 1400 °C;
- the degree of zirconium oxidation reached 4-12 %;
- the mass of produced hydrogen was between 3 and 13 kg.
