Danijel Brezak  
Končar - Electrical Engineering Institute Inc.  
[dbrezak@koncar-institut.hr](mailto:dbrezak@koncar-institut.hr)

Dalibor Filipović-Grčić  
Končar - Electrical Engineering Institute Inc.  
[d Filipovic@koncar-institut.hr](mailto:d Filipovic@koncar-institut.hr)

## ULTRASONIC METHOD FOR TESTING OF POWER TRANSFORMERS

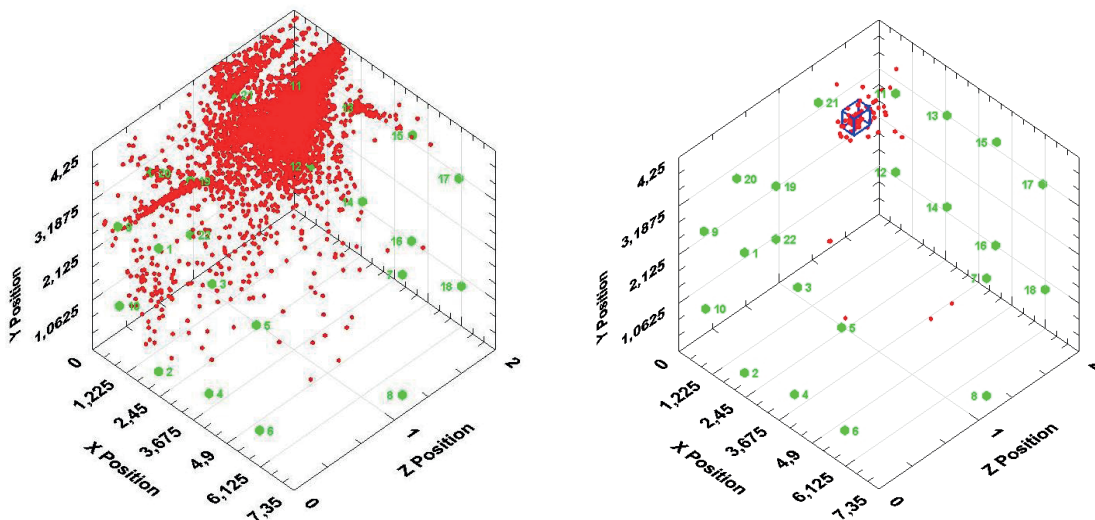
Figure 5. 3-D view of obtained locations before (left) and after the analysis (right)

Ultrasonic testing of transformer 200 MVA, 220/115 kV was initiated by high levels of dissolved gasses in oil, especially ethylene (2122 ppm) and methane (1007 ppm). High levels of these gases indicate a thermal fault, local overheating without the presence of paper.

Highest acoustic activity was recorded by sensors placed in the region of OLTC. Results, before and after analysis are shown on figure 5. During the analysis noises, reflections and mechanical interference was removed, as well as the disturbance originated from the atmospheric conditions (rain, wind etc.). After the analysis locations were obtained within the blue cluster.

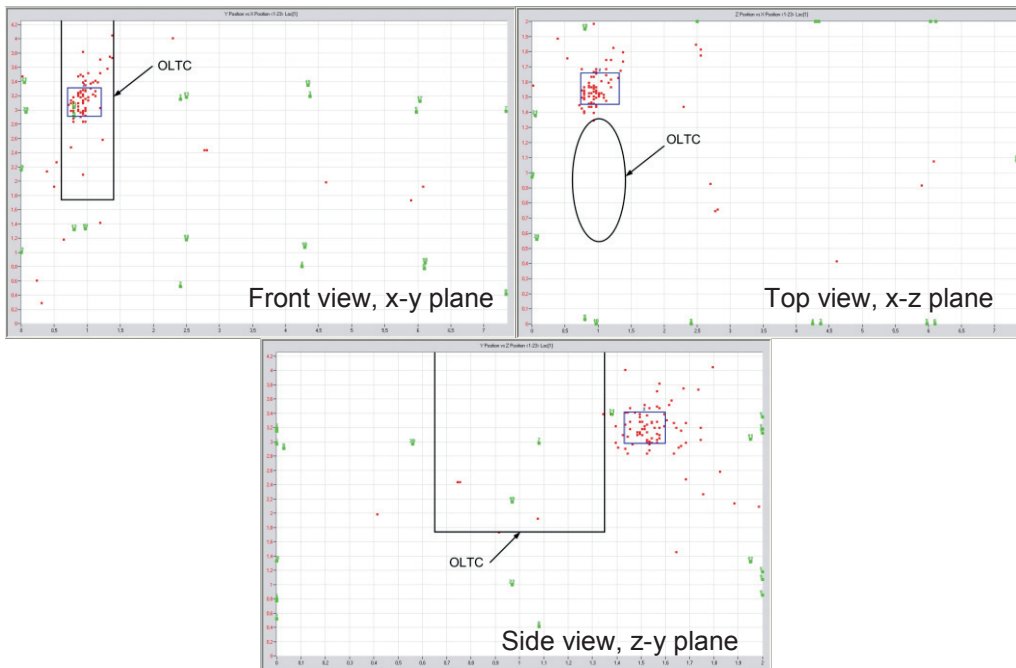
**Figure 6. Obtained locations – front, top and side view**

Different views of the transformer are shown on figure 6 along with the sensor positions and obtained locations. OLTC position was added afterwards. Since the axes are not in the same scale OLTC has an oval shape instead of a circular.

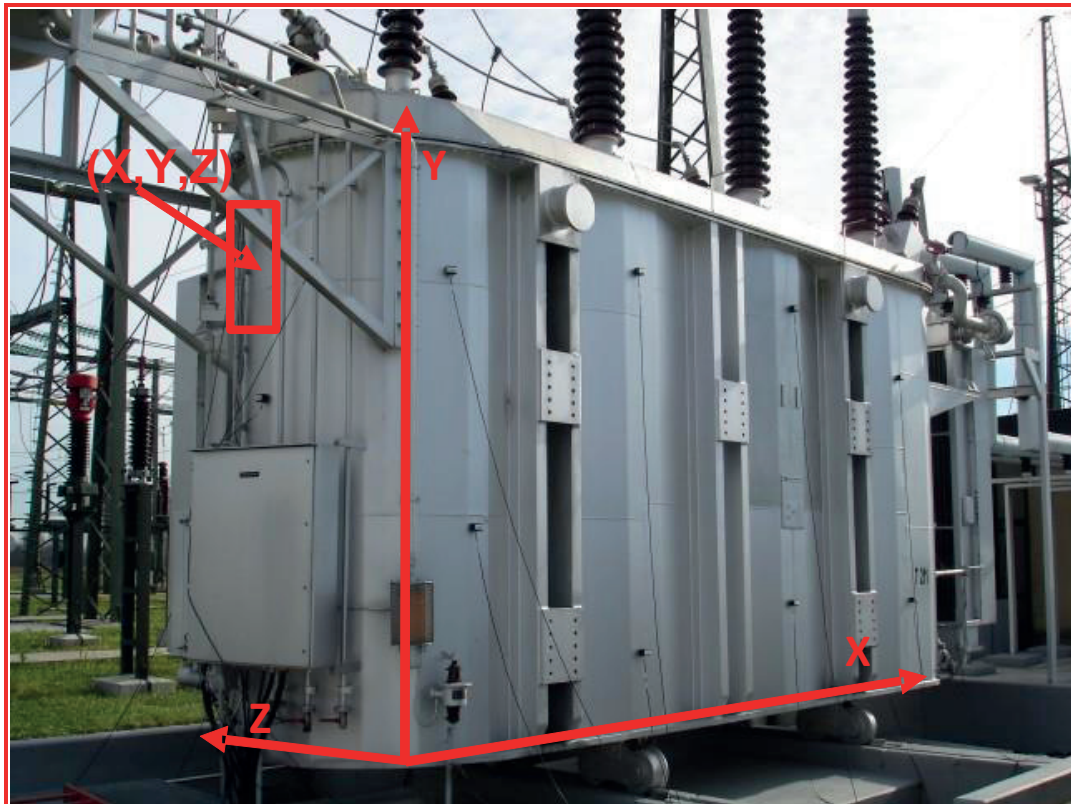
**Figure 7. Area of highest activity**

Obtained locations, a cluster of the highest density, points to a region where some of the contacts of OLTC are placed. Test result could indicate a bad connection between OLTC contacts and outputs of regulating winding. Na The most active part of the transformer is marked with a red square on figure 7.

After the test it has been determined that there was a significant deviation of winding resistance measured in one of the OLTC positions. This position was not used and there was no further rise of dissolved gases.

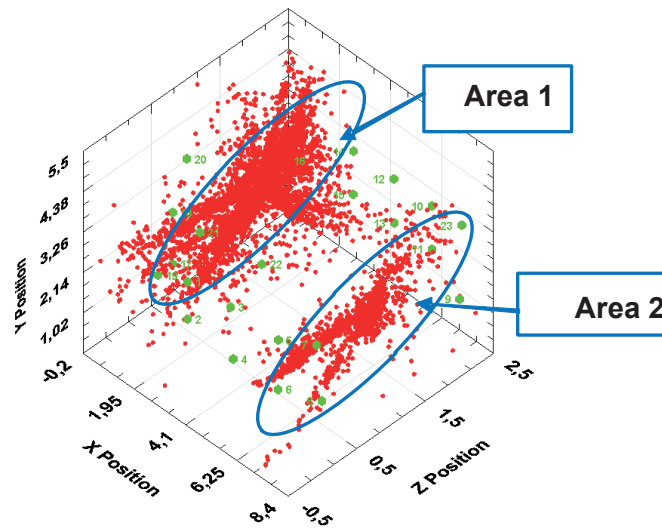
Figure 8. Obtained locations – 3D view – before analysis

During the laboratory tests two independent areas of acoustic activities were obtained. Acoustic activity was recorded even at low voltages (switch on voltage). The positions of obtained locations (red dots) before the analysis are showed in figure 8. One area indicates an acoustic emission source in the region of phase 1U returning core limb (5 limb core), and another, an acoustic emission source in the region of 1W returning core limb.

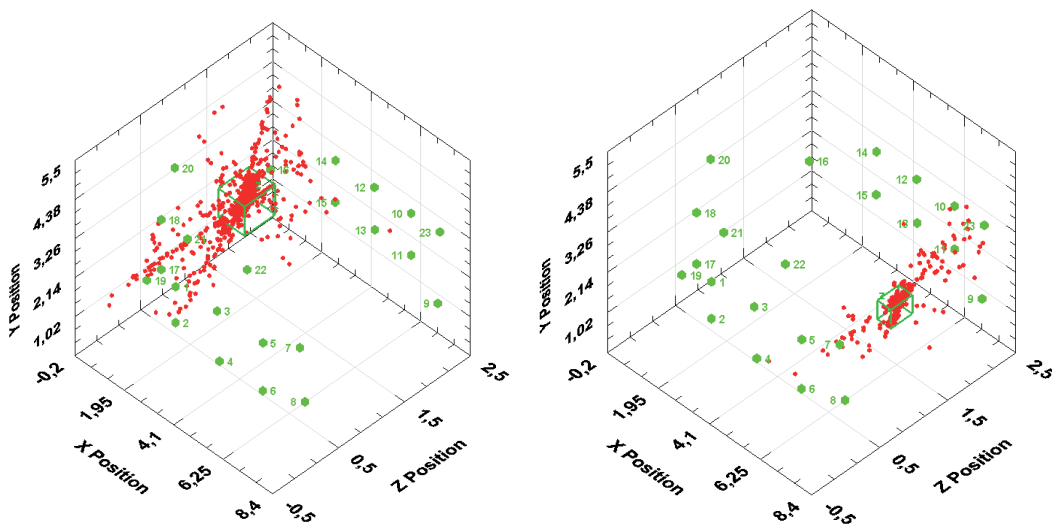
Figure 9. Obtained locations in region of returning core limb 1U (left) and 1W (right)

After analysis, two clusters (green box on figure 9), were obtained (areas were analyzed separately).

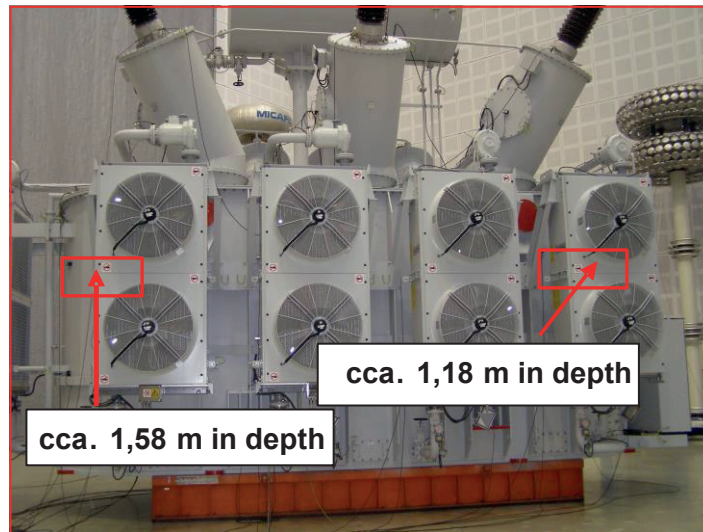
**Figure 10. Areas of high acoustic activities (based on 3D clusters)**

Areas of highest acoustic activity are shown on figure 10 (marked red). This result indicated that there are acoustic emission sources in the region of both returning core limbs.

The transformer was opened and inspected. It was determined that a part of electrostatic screen of returning limb did not have defined potential, i. e. they were not properly grounded and produced sparking.

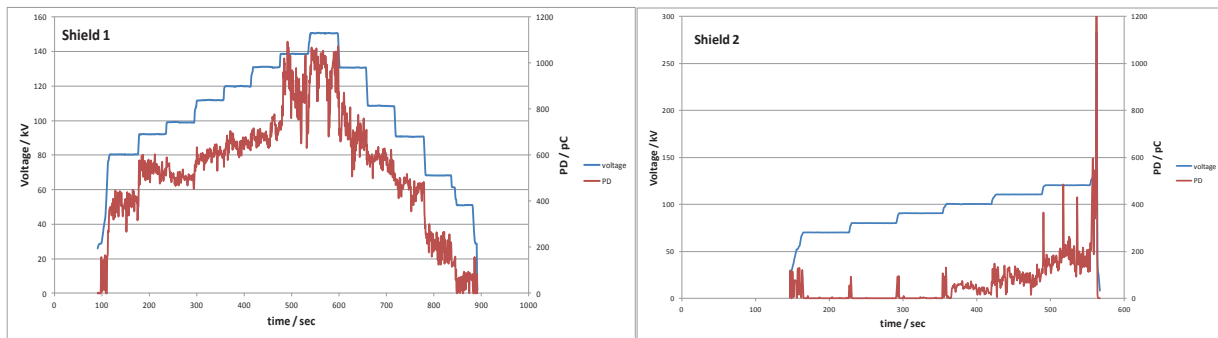
Figure 12. Plot of voltage and PD level vs. test time

Four sensors were placed at the bottom of the test tank. One of the end shields (screen 1, figure 12) showed high PD-s but with very low acoustic activity. This activity is within the range of surrounding noise of an on-site test.

As it is showed on figures 12 and 13, test of screen no. 1 showed very low acoustic activity even when PD levels were above 1000 pC.

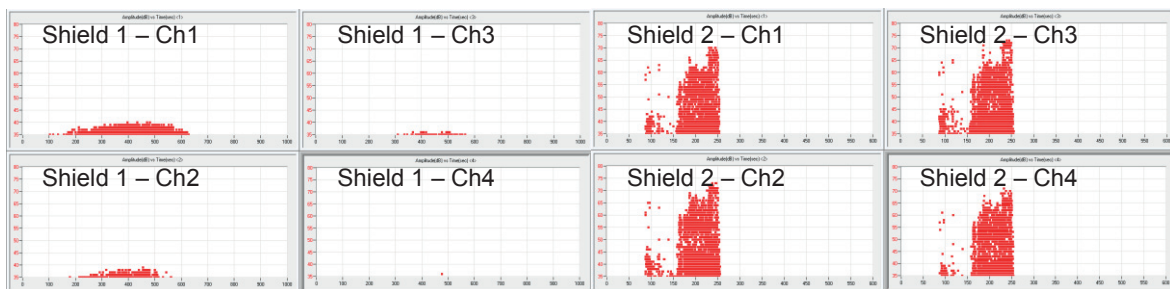
Figure 13. Plot of Acoustic activity vs. test time for both screens

To check the sensitivity of ultrasonic system in the existing test setup, a test of end shield no. 2 with damaged epoxy insulation (screen electrode in contact with oil) was performed. Ultrasonic system detected high acoustic activity even at PD levels lower than 10 pC. Since there was a risk of breakdown the ultrasonic system was shut off. Breakdown of shield 2 occurred at 130 kV.

Therefore it is very likely that the damping of acoustic waves generated in epoxy-resin insulation is too high and cannot be detected by the sensors placed on the tank of the transformer.
