Ivan Šulc  
Končar - Electrical Engineering Institute Inc.  
[isulc@koncar-institut.hr](mailto:isulc@koncar-institut.hr)

## AN ASPECT OF TRANSFORMER INRUSH CURRENT

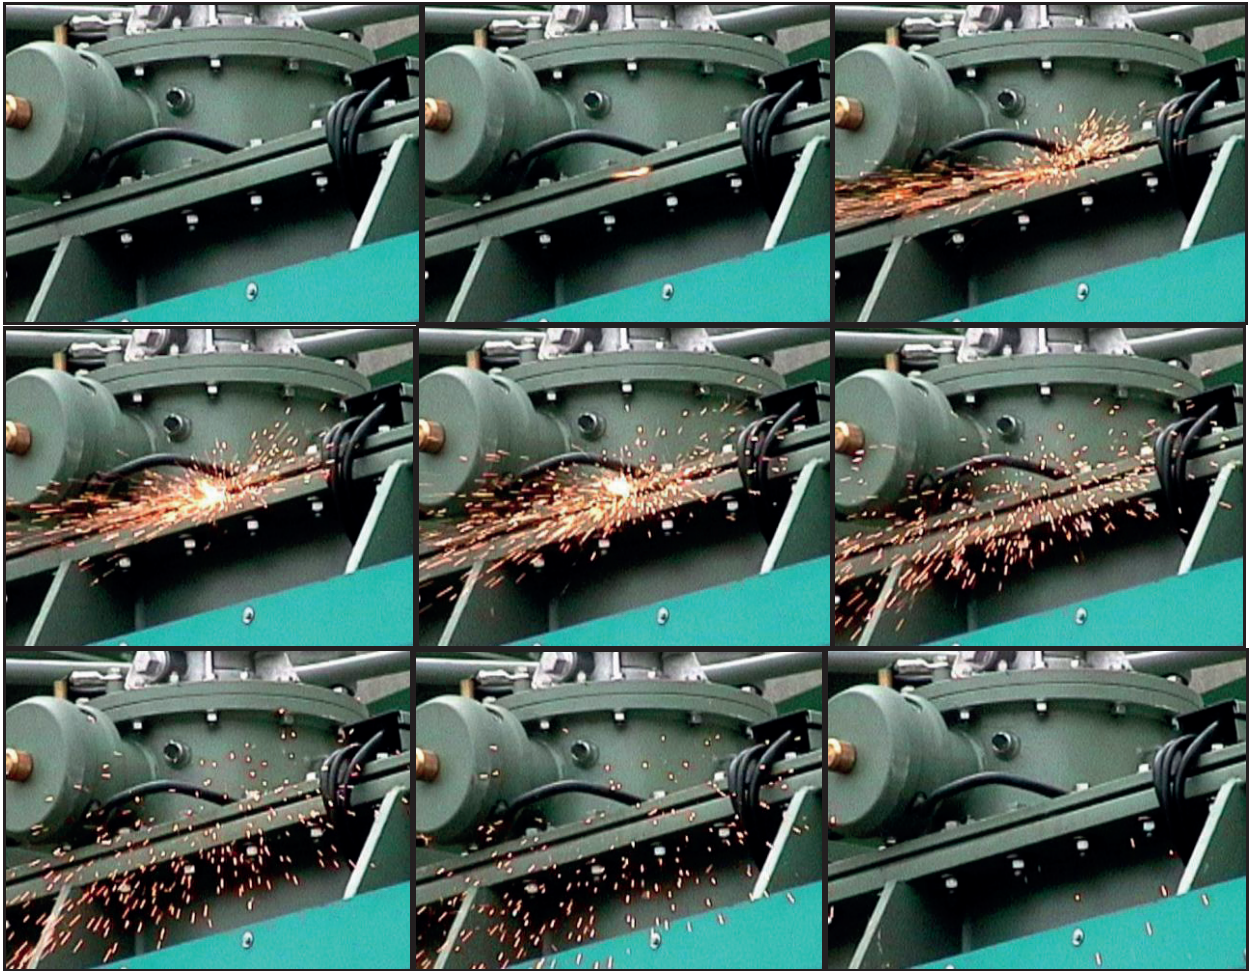
**Figure 1: Sparks between tank cover and tank side (shown in detail) during inrush current event, autotransformer 220 MVA, 220 kV, sequence from left to right and from up to down**

Entire phenomena in Figure 1 lasted in a range of a second. Such phenomenon was observed only on new transformers, mainly on one of the first several energizing or so, and shows a certain random behavior (in the same manner as inrush current), in a wide range of transformer power – from 40 to 500 MVA, and voltages – from 110 to 400 kV; transformers with three limb (3/0) and five limb (3/2) core type, so as from different manufactures. All observations were made on three phase transformers equipped with a bolted tank cover. It should be noted though that single phase transformers, so as three phase transformer with a bolted bell type tank, are much less abundant and this could be the reason why there has been no observations. Spark striking on 40 MVA 110 kV transformer is shown in Figure 2.

It is obvious that the currents calculated in previous chapter, for low jumper resistance, can have result in observed sparks but only if the majority of tank cover bolts are not able to carry the current (non-defined galvanized connection). This means that if many bolts are "insulated" from tank cover or side wall, current can become concentrated and have sparking as a consequence. This is a bit unusual because of a very high specific pressure between bolts and tank metal surface.

It is interesting to raise a question: why is this sparking happening and why has this phenomenon been recognized, by our knowledge, only for the last 15 years approximately? Actually we have no answer to this question, but some strong indication exists. According to our experience, tank coating quality (tank protection against corrosion) increased tremendously during the mentioned period. Today's tank coatings are so hard and firm providing no conductive path between the tank cover and wall in spite of the fact that all of them are properly tightened. This has been proven several times by low voltage resistance measurements performed during some other research. Because of that, the current could be concentrated (in similar manner as is simulated with a test jumper in previous chapter) and produce sparks on the "weakest place" between the tank cover and tank side wall. During transformer service, *caused by lot of similar effects*, a conductive connection between bolts and tank becomes much more likely and this side effect of inrush current event spontaneously disappears. This means that the sparking between the tank cover and wall is striking, but harmless, and will disappear quite soon in transformer service.

Observed sparking can be prevented by the use of welded tank cover, but also by applying several more jumpers between the tank cover and tank side. However, by doing nothing, it will disappear soon.

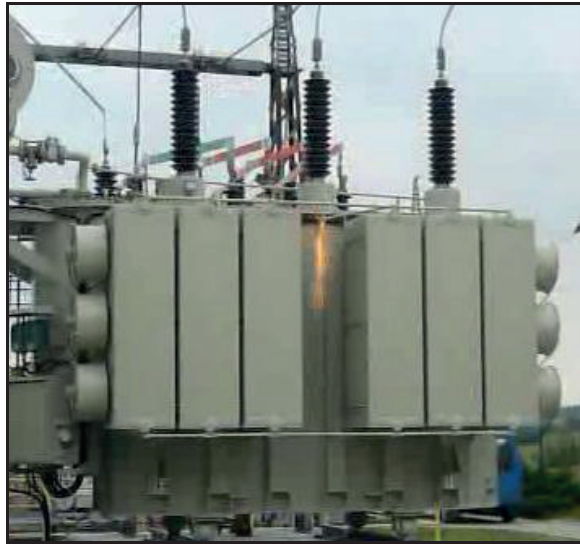
**Figure 2: Sparks on tank during inrush current, transformer 40 MVA, 110 kV**

Figure 1 and 2 show that the sparking may be fairly strong, astonishing the staff. Sparking does not appear on all new transformers. Moreover, it is a rare event observed only in several cases. In one case the phenomenon was observed on an about 30 years old but a completely refurbished transformer and it was also related to first energizing after refurbishment. No sparking striking events appeared on this transformer when it was new. In spite of this initial behavior, transformers operate perfectly without related complaints. Up to now there has been no evidence of any influence of the described phenomenon on dissolved gas analysis (DGA) results.
