Krško NPP Experience with RTD Bypass Elimination

Gordan Janković

Nuclear Power Plant Krško
Vrbina 12, 8270 Krško, Slovenia
gordan.jankovic@nek.si

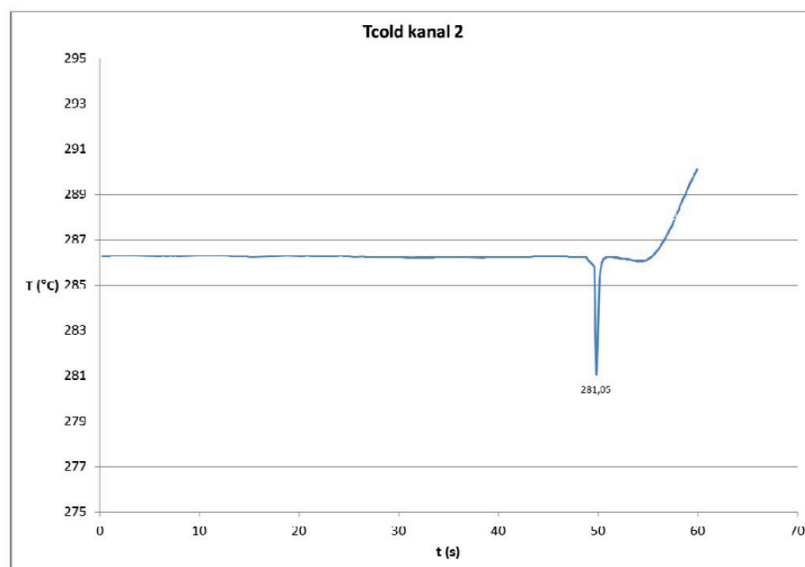
Figure 9: Plant computer trend for protection channel 2 Tcold

As the plant was performing an initial power increase after the outage, at about 90% power, the reactor tripped on OPΔT protection signal. By looking at the trends on the plant computer (as shown on Figure 9 and Figure 10), it could be seen that all temperature signals coming from the field had downward spike. Lag filters filtered out these spikes for the Thot signal, but strong lead/lag filters amplified the spike on Tcold signal, which resulted in large spikes on ΔT signal, so that it went above the OPΔT trip setpoint on 2 out of 4 channels. Reactor operator on shift noted that the trip coincided with reactor makeup water selector switch operation, which was known to sometimes cause irregularities on control equipment, but plant did not have any record of spikes or any irregularities in reactor protection instrumentation. With reactor tripped, the troubleshooting team was able to reconstruct the spikes of varying amplitude on resistance-to-voltage cards (NRA cards) whenever the reactor makeup water selector switch was operated. The cause for that was determined to be operation of up to 12 auxiliary relays that are located in auxiliary relay racks nearby temperature channels. The relays are powered by 118 VAC power source. Since relays did not have any surge protection, whenever a relay was energized or de-energized, voltage spikes of sometimes more than 1000 volts occurred (see Figure 11), which emitted electro-magnetic (EM) pulse. EM pulse is believed to be picked-up by the interconnecting cables and transferred from auxiliary relay racks to reactor protection cabinets, where temperature channel cards were located. Since NRA cards operate with relatively small field signals of about 300 mV, which is then amplified with large gains, they were most susceptible to picking up the EM pulse.

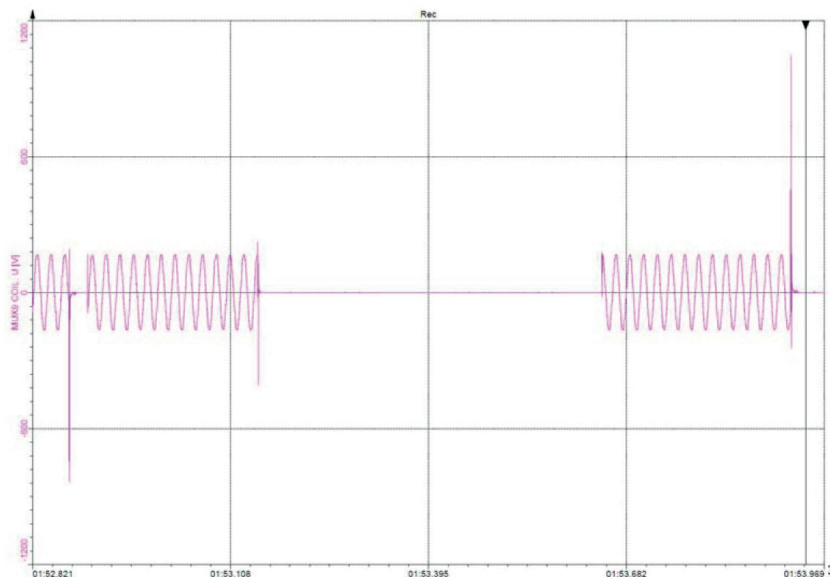
Figure 11: Voltage spikes on auxiliary relay coils

The root cause analysis was performed which identified four contributing causes for the trip: the EM pulse generation by the auxiliary relays, the transfer path for the pulses, the NRA cards input stage susceptibility to EM noise, and OP ΔT protection reconfiguration that made the channel vulnerable to short-term spikes in field signal. In order to prevent such events in the future, three contributing causes were addressed and resolved or mitigated. It was judged that resolution of EM noise transfer to protection cabinets would require significant effort without further improvement to temperature channels noise immunity, and possibly creating new problems.

The EM pulse generation was greatly reduced by installation of the surge protectors on all affected relays, which limit the voltage spikes on the relay coils to 200 volts. These are passive metal oxide varistors, which do not require any maintenance.

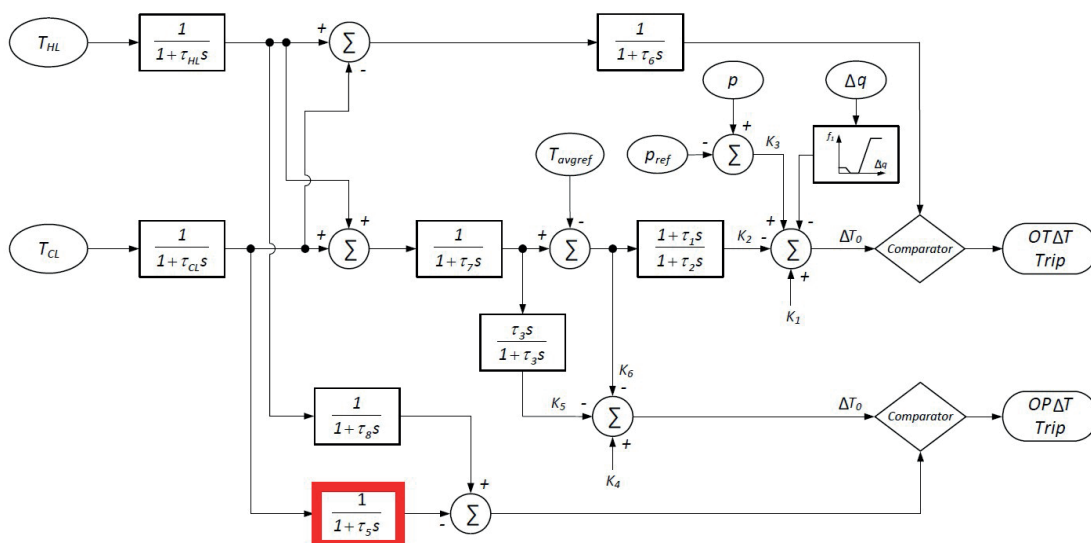
The most complex contributing cause to address was OPΔT protection change that would remain efficient for the mitigation of design accidents and not be over-sensitive to short-term signal disturbances. A sensitivity study [10] was performed where a series of Tcold lead/lag or lag-only filters were compared with magnitude of the Tcold signal disturbance they can filter out without generating a trip signal, and compared with the departure from nucleate boiling ration (DNBR) they still attain (as a measure of reactor protection efficiency). This showed that the implemented aggressive Tcold lead/lag filtering was very conservative and that DNBR margin remains with lag filter on the Tcold signal, while it offered maximum disturbance rejection. Based on this conclusion, Tcold lead/lag filter was replaced with lag-only filter.

Figure 12: OPΔT/OTΔT trip function diagram after Tcold filter change (in red)

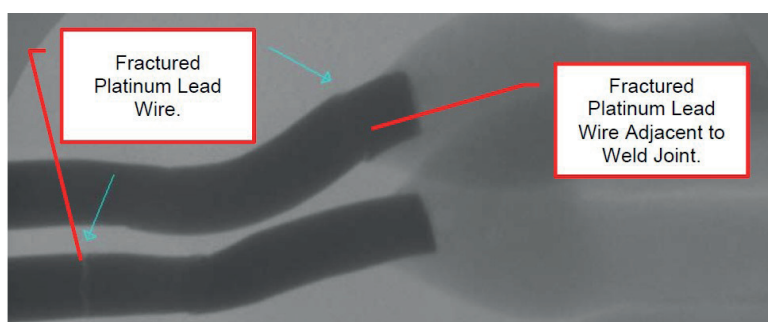
which were also measured on and believed to originate from reactor coolant pumps (RCP). Failed RTD was removed from the thermowell and significant rub marks were observed on several places on RTD sheath (see Figure 14), which supported the assumptions about vibratory environment. The plant conservatively decided to replace all four cold leg RTDs in outage 2015 with spares. The failed RTD unit was shipped to the manufacturer for examination and determination of root cause for the failure. After one cycle of operation in a neutron flux environment the RTD was slightly activated so the manufacturer was only able to perform visual and x-ray examination, because he did not have means to contain radioactive debris that would form with destructive examination. Nevertheless, the cause for the RTD failure was clearly visible as platinum lead wire breaks on the x-ray shots (see Figure 13). The causes for the break however could only be assumed.

Figure 13: X-ray of RTD platinum lead wire fractures

- failed RTD units had insufficient powder potting in the RTD tip region, which resulted in excessive platinum lead wire mechanical loading and failure
- the cross-section of the most of the failed wires showed typical signs of metal fatigue.

- Instead of pure platinum, a higher strength platinum-rhodium alloy material shall be used for RTD lead wires
- The RTD manufacturing process was revised so that better potting was assured
- RTD tip was slightly redesigned to support better potting.

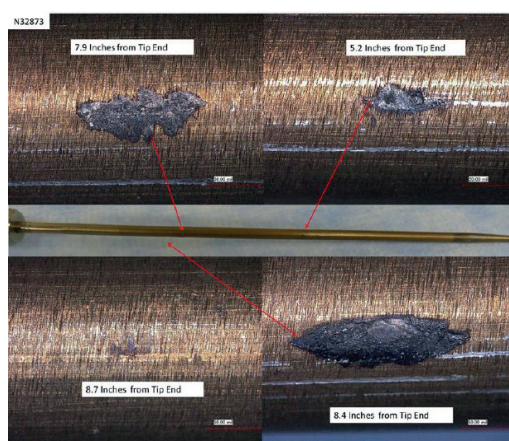
Figure 14: Rub marks on the RTD sheath
