# ANALIZA VELIKOG KVARA U TRAFOSTANICI NA OTOKU KRETI

## THE STUDY OF A MAJOR 2008 SUBSTATION INCIDENT IN THE EPS OF CRETE

Emmanuel Thalassinakis – Thales M. Papazoglou, Iraklio, Crete,  
Greece

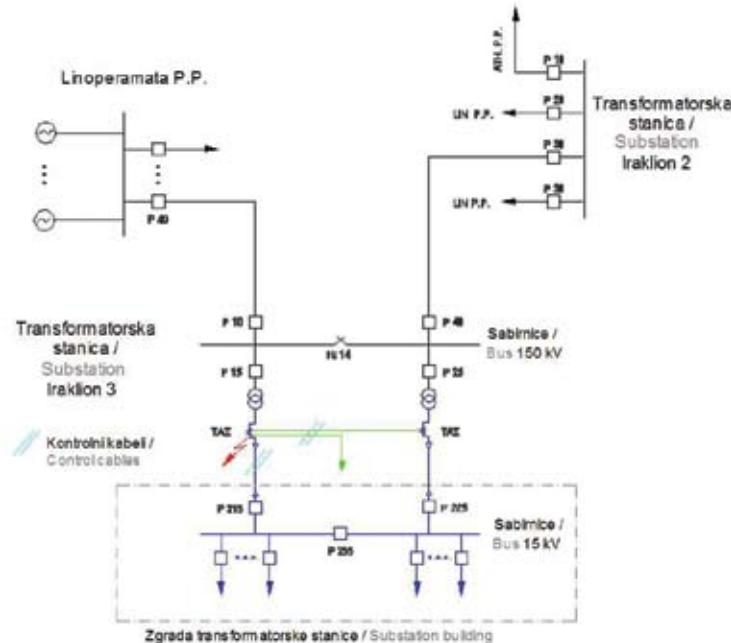
**Slika 1 — Jednopolna shema TS Iraklion 3 s veznim stanicama**  
Figure 1 — Single-line diagram of SS Iraklion 3 with connecting stations

Crvene strelice na slici 1 pokazuju mjesto kvara. Kvar je očito počeo kao jednofazni kratki spoj koji se zbog posledičnog uništenja dijela zaštite u 24 sekunde razvio u trofazni kratki spoj (slika 3).

The red arrows in Figure 1 show the position of the fault. The fault apparently started as a single-phase fault which due to the resulting destruction developed in 24 seconds into a three-phase fault (Figure 3).

Istraga nakon događaja pokazala je da je kvar počeo kao jednofazni kratki spoj srednjenaponskog kabela koji je povezivao sekundar prvog transformatora TS Iraklio 3, samo od točke podzemnog ulaska kabela. Bio je to kvar visokog otpora za koji se zna da ne uključuje diferencijalnu zaštitu transformatora. Zbog topline koju je proizveo kvar, izgorjele su izolacije niskonaponskih kabela zaštite čvorista kondenzatora koji su bili u blizini te je stoga srednji napon bio prenesen na polje kondenzatora uzrokujući potpuno uništenje zbog topline i požara. Osim toga, srednji napon je prenesen na sve zaštitne i kontrolne krugove transformatorske stanice.

Ubrzo nakon toga kvar se razvio u trofazni kratki spoj i izazvao da diferencijalna zaštita transformatora otvari prekidač P215 (slika 1) na sekundarnoj strani transformatora, no nije uspjela otvoriti prekidač P15 (ista slika) zbog uništenja pripadajućeg okidača strujnog kruga. Drugim riječima, kvar nije bio uklonjen. Procjenjuje se da su struje kratkog spoja iznosila 4 933 A. Te su struje tekle neprekidno 16 minuta, stvarajući destruktivnu toplinu koja je rezultirala raširenim požarom na instalacijama transformatorske stanice. Krajnji je rezultat bila značajna šteta na energetskom transformatoru broj 1 transformatorske stanice, te uništenje sve kontrolne i zaštitne opreme, uključujući jedan interni transformator za servisni napon, tri audio-frekvencijska transformatora, itd.

From the post-mortem on-site investigation it became apparent that the fault began as a single-phase MV cable fault connecting the secondary of the first transformer of SS Iraklio 3, just 5 m away from the point of the subterranean entrance of the cable. It was a high resistance fault that is known not to energize the transformer differential protection. Due to the heat produced by this fault, the LV cables of the capacitor node-protection, which were in the vicinity, had their insulations burnt, and therefore the MV was transmitted to the capacitor bay causing complete destruction due to heat and fire. In addition the MV had been transmitted to all the protection and control circuits of the substation.

Shortly afterwards, the fault developed into a three-phase fault causing the differential transformer protection to open the circuit breaker P215 (Figure 1) on the transformer secondary side, but, it failed to open the breaker P15 (same figure) due to the destruction of the corresponding trip-circuit. In other words, the fault failed to be cleared. The fault currents have been estimated to 4 933 A. These currents were sustained for 16 continuous minutes, producing destructive heat that resulted in extensive fires in the substation installations. The end result was that Power Transformer # 1 of the substation suffered extensive damage, as had all the control and protection equipment, including one internal service transformer, three audio-frequency transformers, etc. which were destroyed.

Poukom ovog iskustva, smatra se obavezним odvojiti energetske kable od kontrolnih i zaštitnih kabela provodeći ih kroz potpuno različite kanale. Također, savjetuju se povratne zaštite (engl. back-up) transformatora. Na primjer, trebala bi postojati povratna zaštita u slučaju da diferencijalna zaštita ne djeluje. Stoga bi trebalo uvesti nadstrujnu zaštitu, uz nešto veći vremenski interval, na visokonaponskom prekidaču transformatora. Nadalje, bila bi nužna zaštita od zemljospaja koja je osjetljivija na jednofazne kratke spojeve.

Following this experience, it is considered a must to separate the power cables from the control and protection cables passing them through completely different channels. Moreover, back-up transformer protections are advisable. For example, there should be a back-up protection in case differential protection fails to act. So, a high-current protection should be enacted, at a slightly higher time-interval, at the HV breaker of the transformer. In addition, a restricted earth-fault protection could be necessary, which is more sensitive to single-phase faults.

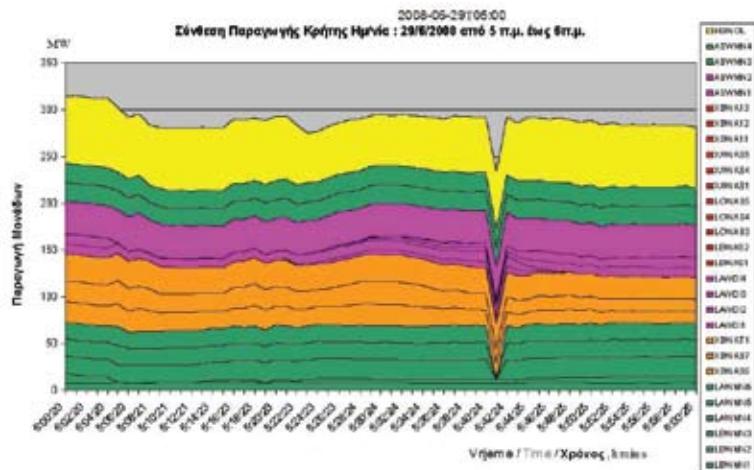
**Slika 2 – Opskrba opterećenjem (vremenski graf u h:min:s) uključujući i poremećaj po incidentu**  
**Figure 2 – Load supply (time-graph in h:min:s) including the incident disturbance**

Na slici 2, različite boje, odozdo prema gore, odgovaraju parnim jedinicama, kombiniranom ciklusu, dizelskim jedinicama, plinskim turbinama i vjetroelektranama.

In Figure 2, different colors, from base upwards, correspond to steam units, combined cycle, diesel units, gas turbines, and wind generation.

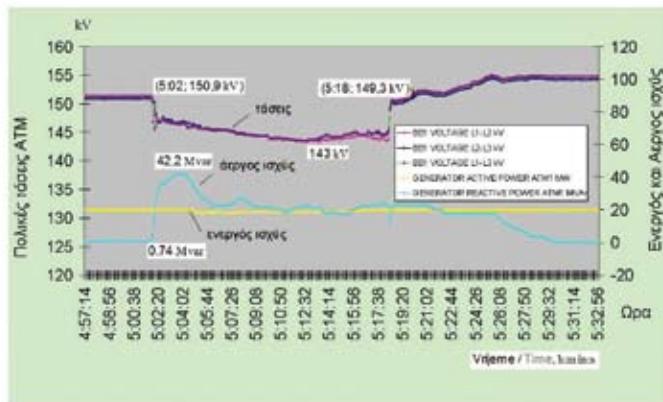
**Slika 3** — Linijski naponi, djelatna i jalova snaga parne jedinice 1 u elektrani Atherinolakos  
Figure 3 — Line voltages, real and reactive power of steam unit 1 – Atherinolakos PS

In the critical period there was a voltage drop at the HV busbars of SS Iraklio 3 to 130,61 kV, while at Ath-

130,61 kV, dok je u Atherinolakosu (zapadna strana otoka) pao na 143 kV gdje je parna jedinica broj 1 (nominalne snage 50 MW) proizvodila 20 MW i 0,74 Mvar prije kvara – porasla je na 42,2 Mvar nakon kvara i kasnije se ustalila na 20 Mvar. Mogućnost proizvodnih jedinica da povećaju proizvodnju jalove snage pomogla je održanju prihvatljivih razina napona i tako je izbjegnut opći raspad. Na slici 3 se mogu vidjeti linijski naponi kod jedinice Atherinolakos broj 1 kao i proizvodnja djelatne i jalove snage u vremenu oko kvara.

erinolakos (west-side of the island) fell to 143 kV where the steam unit #1 (nominal power 50 MW) was generating 20 MW and 0,74 Mvar before the incident – went up to 42,2 Mvar after the incident and leveled-off at 20 Mvar later. The capacity of the units to increase their reactive generation helped in sustaining voltage levels acceptable and to avoid a general blackout. In Figure 3 we can see the line-voltages at the Atherinolakos unit #1 as well as the real and reactive power generation around the incident.

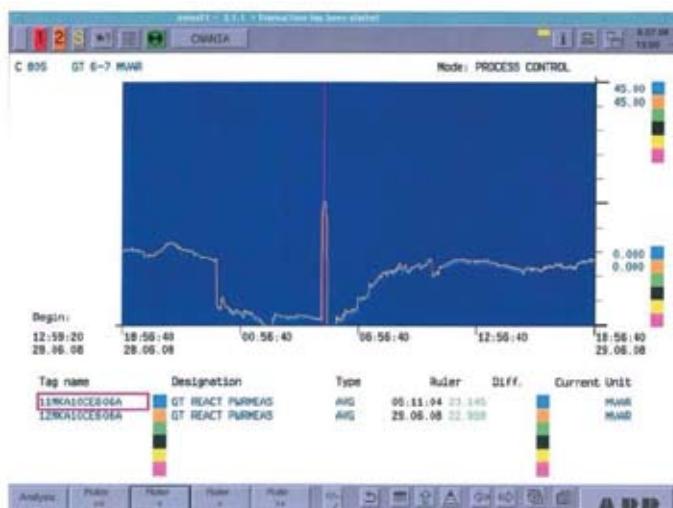
**Slika 4** — Jalova snaga plinskih turbina u postrojenju kombiniranog ciklusa u Xylokamari  
Figure 4 — Reactive power of GTs of Combined cycle unit at Xylokamara

Na slici 4 može se vidjeti proizvodnja jalove snage dvije plinske turbine u postrojenju kombiniranog ciklusa Xylokamara (istočna strana Krete). Ponovno se može vidjeti povećanje proizvodnje jalove snage u kritičnom razdoblju – koje je išlo gotovo od 0 Mvar na 23,145 Mvar i 22,998 Mvar za pojedini plinski turbinu.

In Figure 4 we can see the reactive power generation of the two gas turbines of the combined-cycle unit at Xylokamara power station (east-side of Crete). Again we see the increased reactive power generation at the critical period, which increased from close to 0 Mvar before the incident to 23,145 Mvar and 22,998 Mvar for each turbine.

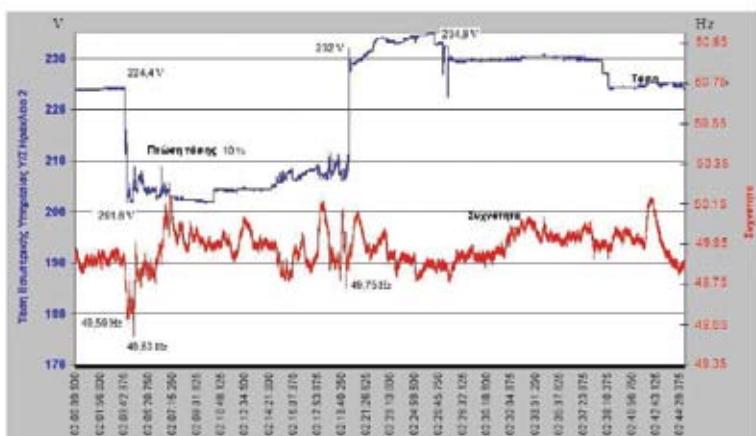
**Slika 5** — Vremenski grafovi napona i frekvencije izmjereni na TS Iraklio 2  
Figure 5 — Voltage and frequency time-graphs measured at Iraklio 2 substation

Na slici 5 može se vidjeti napon i frekvencija izmjeneni na TS Iraklio 2. Vidi se da je na početku kvara, zbog gubitka dvije jedinice (parne jedinice broj 3 Linoperamata sa 7 MW opterećenja, i dizelske jedinice broj 4 Linoperamata s 10,5 MW opterećenja), frekvencija pala na minimum od 49,53 Hz.

In Figure 5 we can see the voltage and the frequency measured at the SS Iraklio 2. We see that at the beginning of the incident, because of the loss of two power units (steam unit #3 Linoperamata with 7 MW load, and Diesel unit #4 Linoperamata with 10,5 MW load), the frequency dropped to a minimum of 49,53 Hz.
