DIJAGNOSTIČKI PREGLED RASPADA ELEKTROENERGETSKOG SUSTAVA NA OTOKU RODOSU DIAGNOSTIC REVIEW OF A BLACKOUT IN RHODES

Prof Papazoglou, Th. M., PhD, Prof Papazoglou, M. T., PhD,
The Technological Education Institute of Crete,
P.P. Box 1939, Iraklio, Crete, Greece

Prof Thalassinakis, E. J., PhD, Prof Tsihlikakis, Ch., PhD, Prof
Hatziargyriou, N. D., PhD, The Greek Power Public Corporation,
The testing Research and Standard Center – DEH S.A.,
32 Halkokondili Street, 10432 Athens, Grece

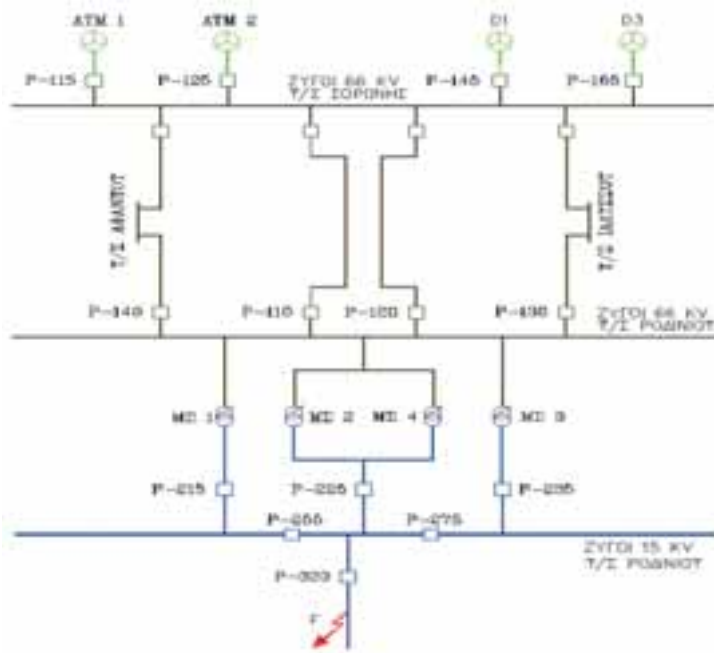
Slika 1
 Jednopolna shema sustava na početku smetnje
 Figure 1
 One-line diagram of the system at the start of the fault

The fault occurred at the Rhodini substation on the distribution line fed through the breaker P-320 from the 15 kV bus, as shown in Figure 1. Following the fault, protection was activated and tripped the breakers P-320, P-255 and P-225. As a result of the fault, a wooden pole of the distribution line burned and had to be replaced later. The weather was severe at the time of the fault, with strong wind spraying sea water droplets over the line insulators, thereby increasing the likelihood of a flashover. Post-mortem examination found the jumper wire for the middle phase conductor (in a horizontal arrangement of the 3 phases) cut at another wooden pole of the same distribution line. The same thing also happened to another pole of the same line where, in addition to a broken middle jumper wire, its porcelain insulators were also broken. This would most likely imply that these were the results of the fault current. This initial fault was finally cleared at about 13 sec after it happened. However, 19 sec after the fault clearance, Steam Unit #1 was lost, and 2 min and 45 sec after the fault clearance Steam Unit #2 was lost, resulting in the blackout.

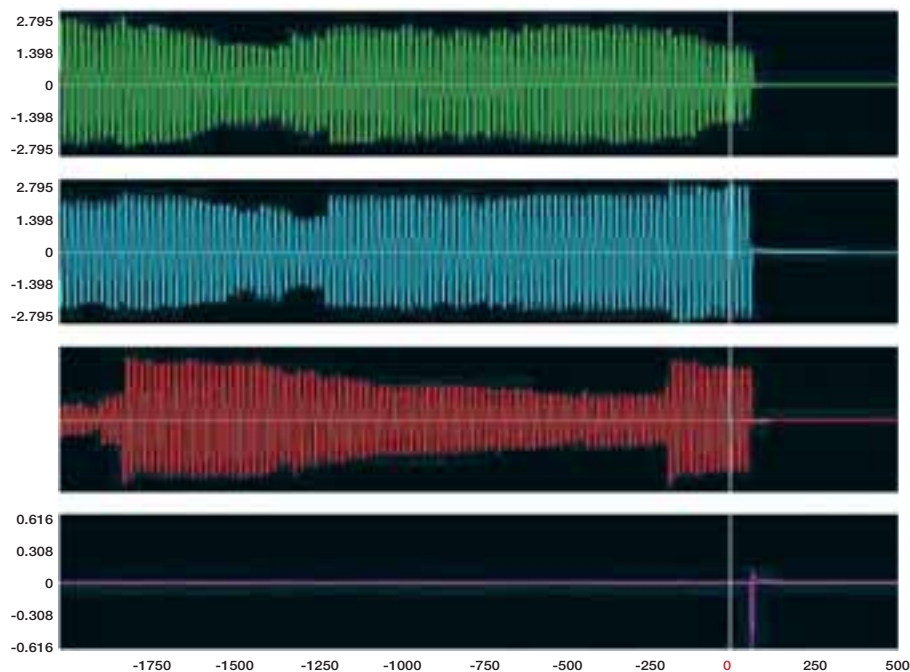
P-255 (Figure 2) breakers, which showed zero earth current. It could also be observed that the fault impedances varied randomly with time, suggesting that the electric-arcing of varying spans was the cause. Oscillograms 1 and 2 (Figures 3 and 4) show the voltages at the 66 kV buses at Rhodini and the currents at the 66 kV breaker P-110, respectively. These oscillograms show oscillation developing as time progresses. Subsequent time Oscillograms 3 and 4 (Figures 5 and 6) show this (100 Hz frequency) oscillation more clearly. This oscillation is sustained to the end (as seen in Oscillogram 5 (Figure 7)). This could indicate that the automatic voltage regulators (AVR) need adjustments.

Slika 2
Vremenske krivulje izmjeničnih struja faza a, b, c i uzemljenja na prekidaču P-255
Figure 2
Time curves of the alternating currents of Phases a, b, c and ground at breaker P-255

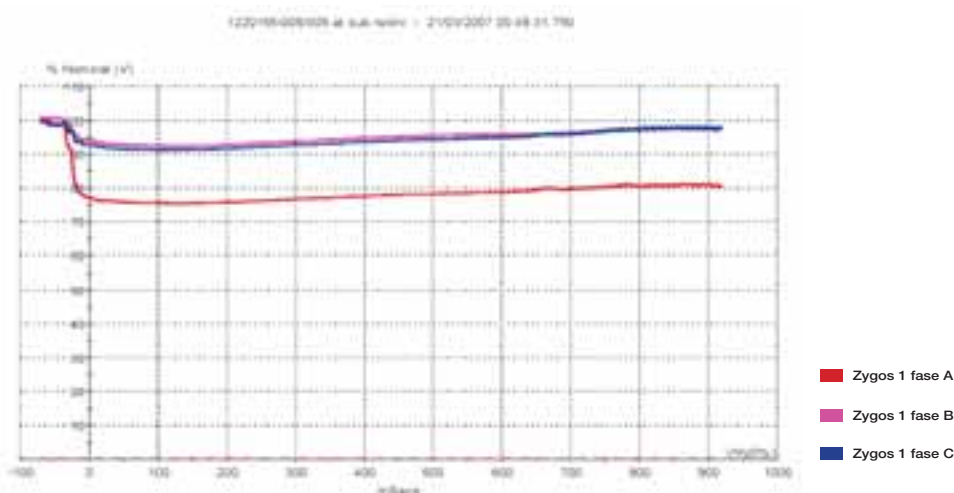
Slika 3
Oscilogram 1 – Naponi na sabirnici 66 kV na trafostanici Rhodini (početak gubljenja struje iz voda)
Figure 3
Oscilogram 1 – Voltages at the 66 kV bus at Rhodini (the fault begins)

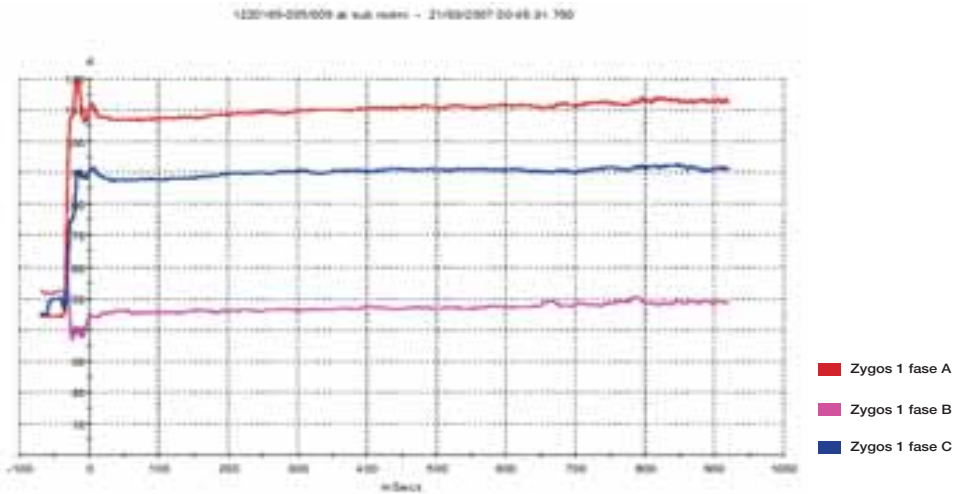
Slika 4
 Oscilogram 2 –
 Struje zabilježene
 na prekidaču 66 kV
 P-110 na trafostanici
 Rhodini
 Figure 4
 Oscillogram 2 –
 Currents registered at
 66 kV Breaker P-110
 at Rhodini

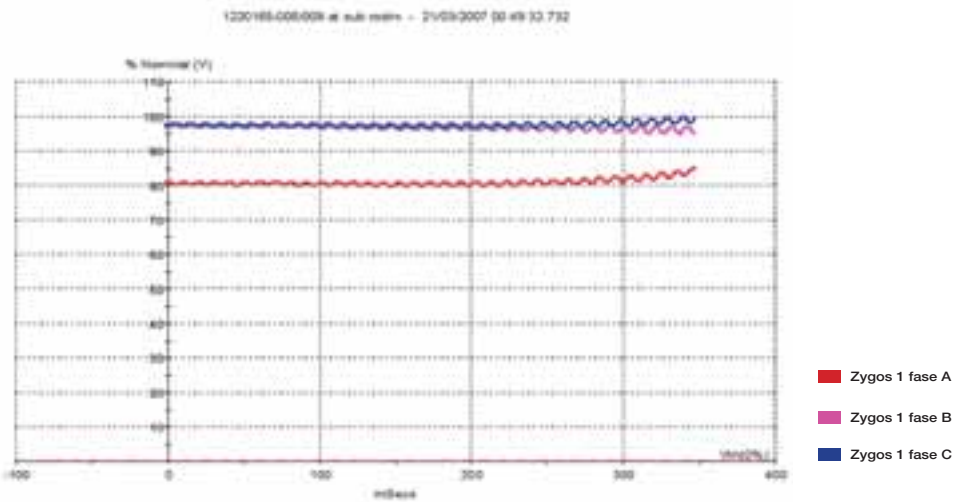
Slika 5
 Oscilogram 3 – Naponi
 na sabirnici 66 kV na
 trafostanici Rhodini
 Figure 5
 Oscillogram 3 –
 Voltages at 66 kV bus
 at Rhodini

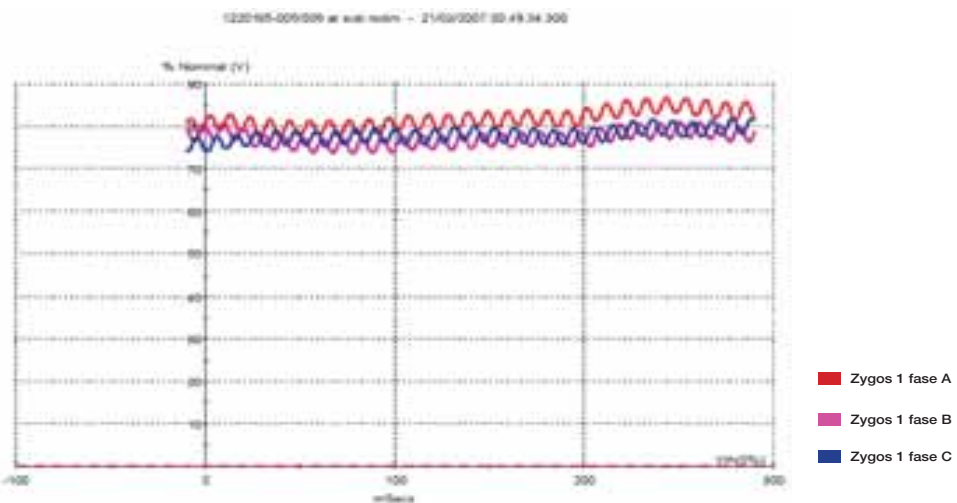
Slika 6
 Oscilogram 4 – Naponi
 na sabirnici 66 kV na
 trafostanici Rhodini
 Figure 6
 Oscillogram 4 –
 Voltages at 66 kV bus
 at Rhodini

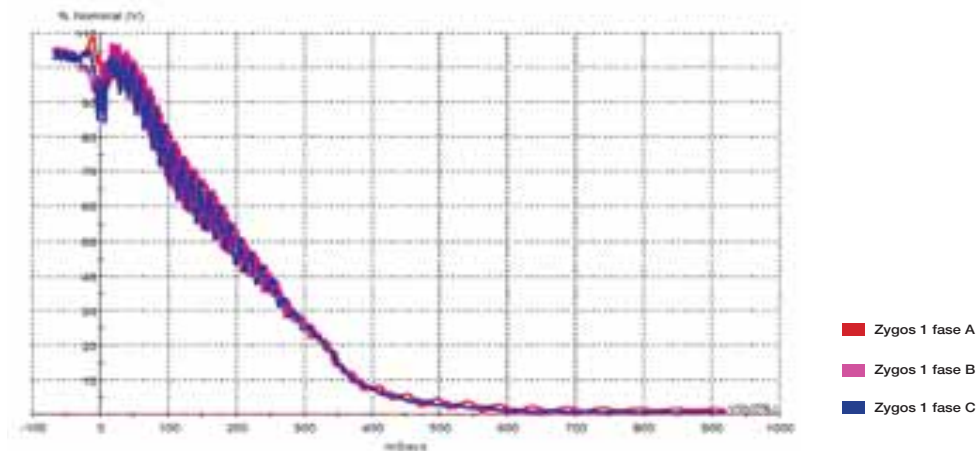
Slika 7
Oscillogram 5 – Napon na sabirnici 66 kV na trafostanici Rhodini (nestanak struje vidljiv na kraju)

Figure 7
Oscillogram 5 – Voltage at 66 kV bus at Rhodini (blackout seen at the end)

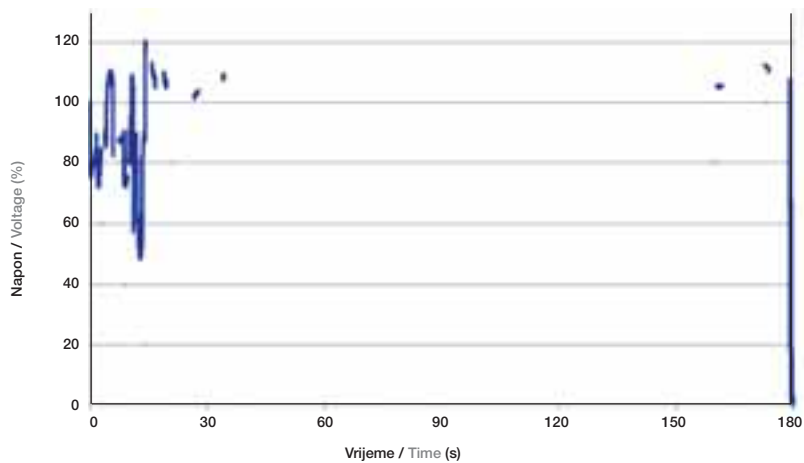
From the voltage oscillogram, one can calculate the voltage magnitude as a function of time, from the occurrence of the fault up to the voltage collapse, as shown in Figure 8.

Slika 8
Varijacija napona na sabirnici 66 kV (u %) tijekom smetnje

Figure 8
66 kV bus voltage variation (in %) during the disturbance

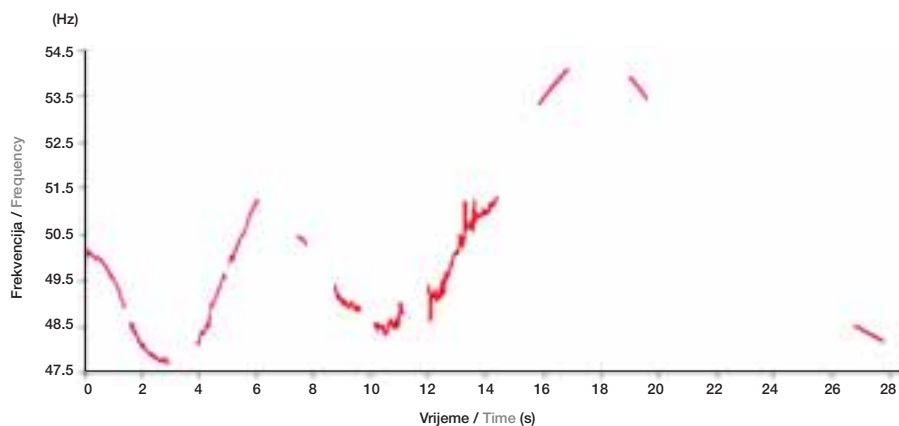
In the course of the disturbance, wide frequency swings were registered. The respective data are shown in Figure 9. In this figure, one can see the minimum frequency of 47,7 Hz (2 s after the start of the disturbance), and the maximum frequency of 54 Hz (16 s after the start of the disturbance).

Slika 9
Trend varijacije frekvencije zabilježen tijekom smetnje

Figure 9
Frequency variation trend registered during the disturbance
