Corrosion Detection and Surface Repair with Coatings on Condensate Storage Tanks Internal Surfaces

Matija Guliš, Sanja Smirić, Lenart Pušnik

Keywords — Corrosion, Condensate Tank, NDE, Coating, Aging Management

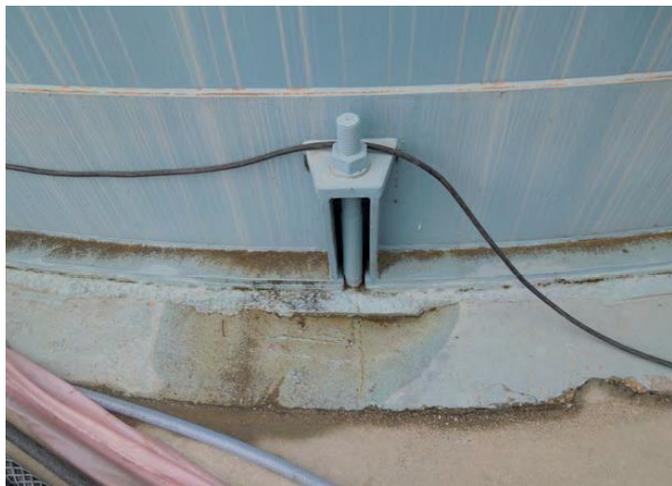
Fig. 2: Possible signs of leakage on tank 1

There was a concern that the tanks are leaking because there were often small puddles of water nearby the tanks (Figure 2) although there were no measurable changes in the levels of tanks. The tanks are designed as a single hull construction, so there is no indication if a small leak is present. The first concern, that there might be some leaks present on tank no.1 was reported through the Corrective Action Program (CAP) already in 2013 [3]. The following inspection in 2013 was a visual inspection with the addition of ultrasonic (UT) thickness measurement by the 25 cm grid and did not find any deviations from the normal state of the component. Concern for degradation of bottom steel plates was still present, because of the scarcity of the UT thickness measurements. For the following outage in 2016 draining of both tanks was not planned, so only during the outage 2018 complete inspection was possible.

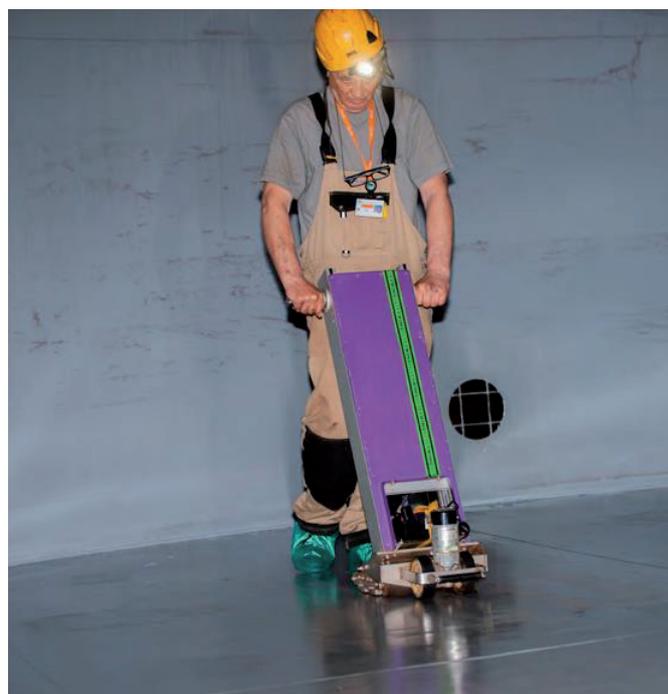
Fig. 5. Inspection of bottom plates using MFL detection scanner.

Inspection of the bottom plates with the MFL method (Figure 5) was performed due to the determination (identification) of pitting corrosion from underneath (bottom side of the plates).

MFL inspection confirmed damage on the bottom plates from underneath (inaccessible side of the tanks) on both condensate storage tanks. In all locations where damage was detected, additional ultrasonic inspections were performed in order to perform the sizing of the located damage. All locations detected with MFL were confirmed with the ultrasonic inspection.

Two locations with corrosion damages were confirmed on the floor plates on condensate tank CY101TNK-001. Six locations with corrosion damage were confirmed on the lower part of floor plates and two locations with mechanical damage on the upper surface of floor plate on condensate tank CY101TNK-002 [4].

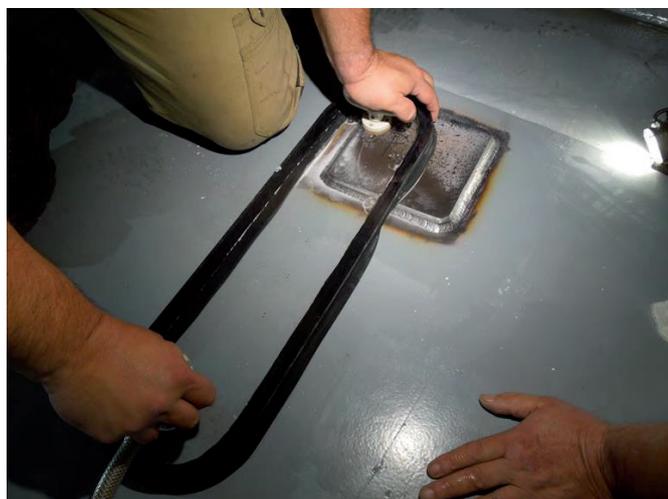
Fig. 6 Vacuum box inspection of welded patch

Inspection of the bottom plates with welded patches and adjacent welds with the vacuum box method did not reveal any damage that cause leakage on condensate tanks [4].

All damaged locations were repaired with welded patches and examined with the vacuum box method.

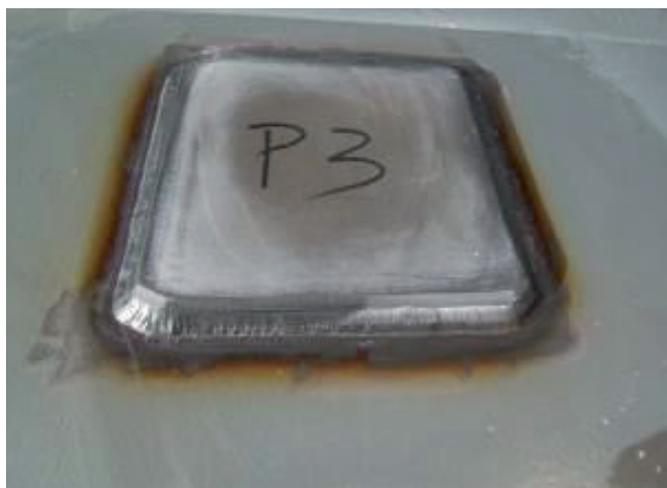
Fig. 12. Steel plate inside CY tank

In outage 2018 CY101TNK-002 were emptied so two (2) steel plates inside CY101TNK-002 were coated with coating material Belzona 139iT (working order 126432, Figure 12 and 13). The material application was performed in accordance with product data sheet (PDS) requirements. After drying of coating system several measurements were carried out: dry film thickness, adhesion testing, and solvent resistance rub [12]. It was confirmed that the coating is properly dried and applied before closing and filling the condensate storage tank.

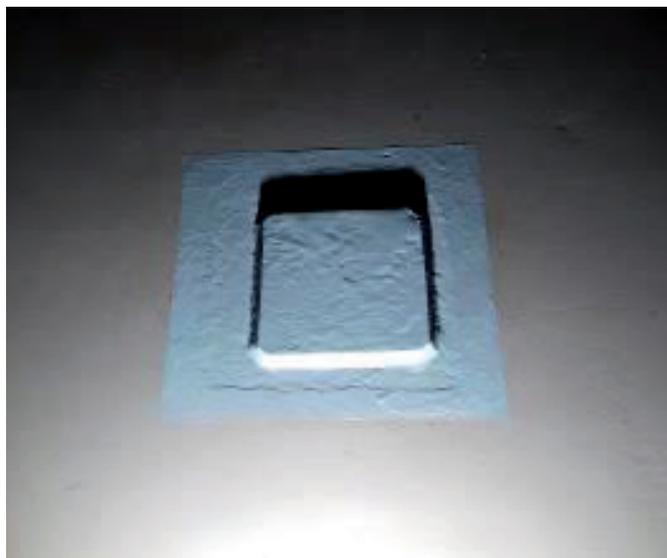
Fig. 13. Coated steel plate inside CY tank

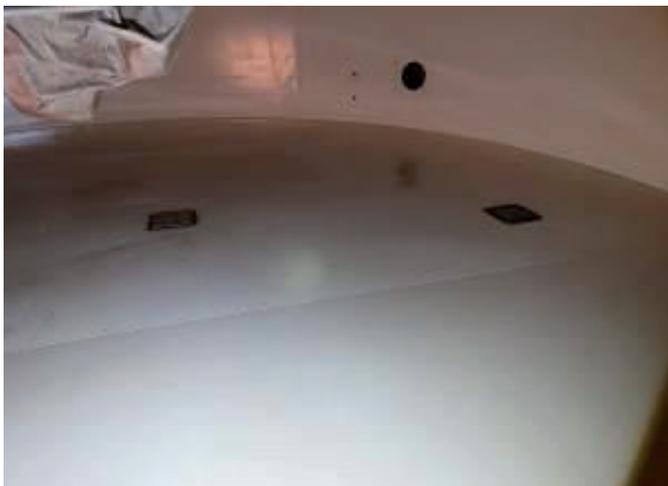
Fig. 14. Steel plates inside CY tank

During the next outage in 2021 seven (7) steel plates inside CY101TNK-001 were coated (work order 166115, Figure 14 and 15). All required activities were implemented to ensure the adequacy of execution of coating application (DFT and adhesion measurement, solvent rub test).

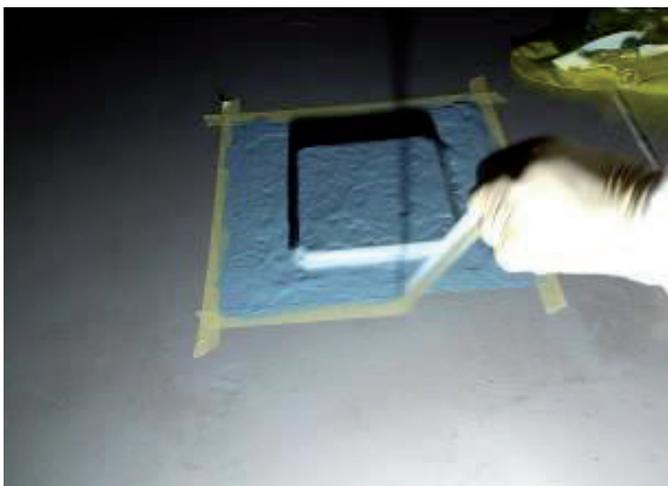
Fig. 15. Coated steel plate inside CY tank
