Mechanical and 1st Chemical Cleaning of NEK Steam Generators

Robert Kelavić, Marko Turalija

Summary — Sludge removal is performed on two steam generators (SG's) at the Krško Nuclear Power Plant (NEK) during every outage. SG's are a meeting point of five major plant systems: Reactor Coolant System (RC) on the primary side and four systems on the secondary side – Auxiliary Feedwater System (AF), Blowdown System (BD), Main Feedwater System (FW), and Main Steam System (MS). Sludge removal activities take place on the secondary side of the SG's on the top of the tube sheet. It always consists of classical Sludge Lancing (SL) which is done by spraying water at different angles (30°, 90°, 150°) between the tube gaps in the steam generator tube bundle with a pressure of around 220 bars. Another method is Inner Bundle Lancing (IBL) which means spraying water directly inside the tube bundle with a traveling lance tape with a spraying nozzle at the end. Water is sprayed at an angle or directly on the top of the tube sheet with a robot-guided manipulator which is placed inside a steam generator. The manipulator and therefore the spraying action is controlled by an operator and at times it is

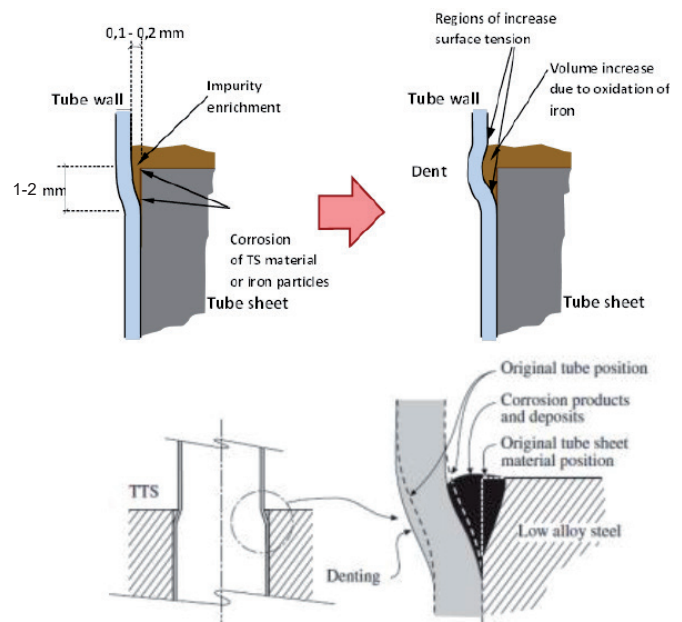
Fig. 1: Origination of dents on TTS

Denting is the mechanical deformation of the Steam generator tubes due to the external pressure forces acting on the outer diameter. When rapid growth of the material trapped in the crevices of tube-to-tube sheet occurs it causes a reduction in the tube diameter. Historically this degradation mechanism was mostly reported in crevices between tube-to-tube support plates, but recently the mechanism is seen as in NEK case in the tube-to-tube sheet locations despite the better tube material (690) than historically more susceptible alloy 600 and alloy 800.

The formation of the initial crevice in a tube-to-tube sheet is a consequence of the manufacturing process. Since it was not advisable to expand the tubes till the very top of the tube sheet due to the possibility of overexpansion and causing an initial crack, the hydraulic expansion was suspended 1–2 mm below TTS and therefore creating a small crevice in the described area.

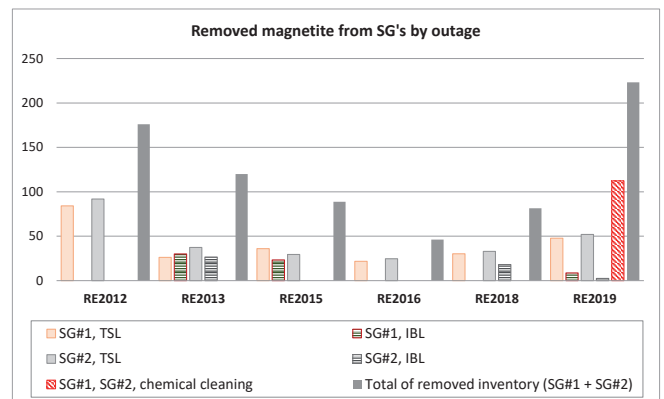
Fig. 7: Balance sheet of removed magnetite from SG's since 2012

The results of mechanical and chemical cleaning of the Krško NPP steam generators in the outage of 2019 are satisfactory, particularly in terms of the amount of removed sediment: 223 kg out of an estimated 290 kg. The estimation included total sludge inventory in the tube sheet area up to a height of approximately 1m. However, we can be less satisfied with the fact that we have not been able to clean both top-of-tube sheets (TTS). After the finished activity and "Lessons learned" we can now summarize the influencing factors, good and bad experiences, and give an evaluation of performance.

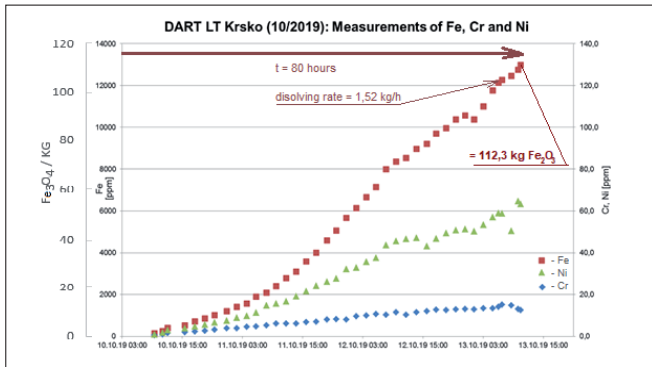
Fig. 8: Concentration rate of Fe, Cr, and Ni in EDTA solution during NEK application

In October 2018, the length of the chemical cleaning activity was set based on the maximum length of the planned outage which was 28 days. At that time, the planned duration of the chemical phase was 80 hours, although the contractor's recommendation was from 100 to 110 hours. In addition, the "Performance Test" was performed at a time of $t \approx 100$ hours. Due to other interconnected activities such as SL, IBL, VT, and FOSAR, no additional time was available in the overall Outage Plan.

At the moment when the dissolving rate of Fe was 1.52 kg/h, we discussed the possibility of process extension. The contractor proposed to extend it to 94 hours, which would provide 6 hours of "Safety margin" based on the 100-hour "Performance Test" qualification. We organized a meeting to extend the activity on the critical path, but during the meeting trend slowed down and the additional extension time was not agreed upon. Assuming that the chemical cleaning phase was prolonged, likely another 25 kg of Fe or more would be dissolved ($1.36 \times 25 = 34 \text{ kg Fe}_3\text{O}_4$). This would further improve the overall balance and reduce the hard deposits area. It should also be noted here that the amount of dissolved Ni and Cr was much lower in the chemical treatment than in the Qualification Performance Test, which means that there was no significant impact on the materials or systems.

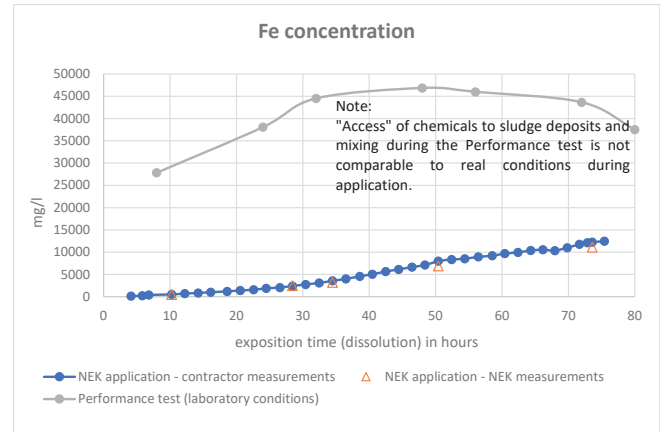
Fig. 9: The dynamics of real-life dissolution in the Krško NPP compared to the Performance Qualification test.

2019 outage dissolutions of Fe or Fe_3O_4 in EDTA solution was significantly slower and smaller in the site-implementation process than in the Performance Qualification Test under laboratory conditions at contractors' facilities, where previously removed (soft) sediment from the Krško NPP was used.

- The hard sediment in the steam generator is compact, a kind of "concreted magnetite" that has been formed layer after layer since the replacement of SG's in 2000. Magnetite used in the "Performance test" was in the form of soft sludge like wet powder compared to hard sediment in the steam generator that had to be dissolved layer after layer again. The process was therefore slower and less efficient than in the laboratory.

- Mixing the medium in a laboratory autoclave was much more efficient than with the actual process in steam generators, where the tube bundle represents a large hydrodynamic flow resistance. Kinetics of a chem. reaction in the steam generators was, therefore, smaller and the process slower.

- The chemical composition of soft sludge is not the same as that of hard sediment. The presence of silicon (Si) and aluminium (Al) is known to have a negative effect on the dissolving of magnetite because it promotes the formation of highly resistible deposits. The last exact chemical composition of sediments is from the outage of 2012. The Si content increased from 2004 (the first analysis of sludge morphology) to 2012. Al in sediments (2004, 2006, 2009, and 2012) has not been reported.

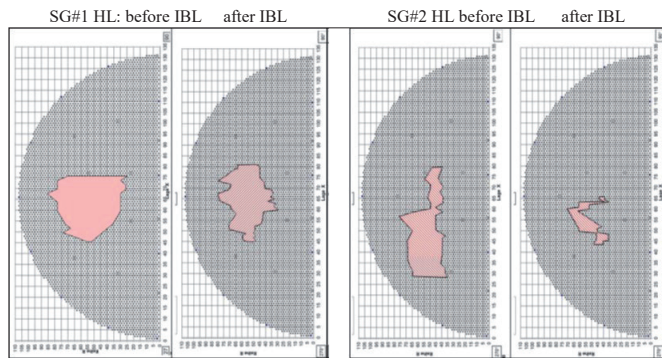
Fig. 10: Hard sludge deposits on Hot Legs of SG#1 and SG#2 before and after IBL

From the large amount of soft sediment removed on SG #2, it was concluded that on SG #1 a chemical dissolution of soft sludge took place which could have been removed by SL if the sequence of sludge removal was the same as on SG #2. Based on chemical principles and kinetics, the chemical reaction of dissolving the soft granulate* is faster, rather than the hard layers of magnetite, which at that time were mostly covered with soft sludge. Access to hard sludge to EDTA was severely restricted and this is the reason that the chemical dissolution of hard sediment at SG #1 was not as effective as at SG #2. Basically, at SG #1, we believe we used a chemical process to remove a lot of soft sludge that would be easier to remove with SL. Therefore, the final mass of sludge was smaller. (Soft granulate*: a mixture of dust and small moving particles of soft sludge of different sizes on the TTS).

The surface area of hard sludge at the top of the tube sheet (TTS), which is a basic precondition for the formation and progression of the denting mechanism, decreased largely on SG #2 than it did on SG #1 after all removal activities. We expected similar sludge removal efficiency on both SG's but the distinction in the sequence of the mechanical and chemical cleaning process is probably the reason for the resulting differences.

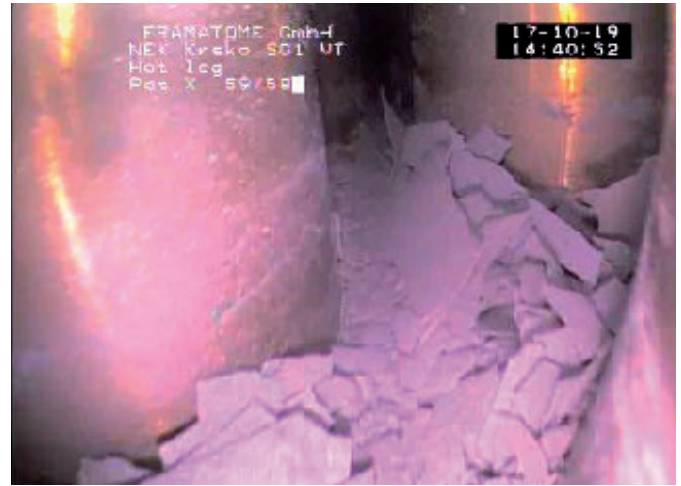
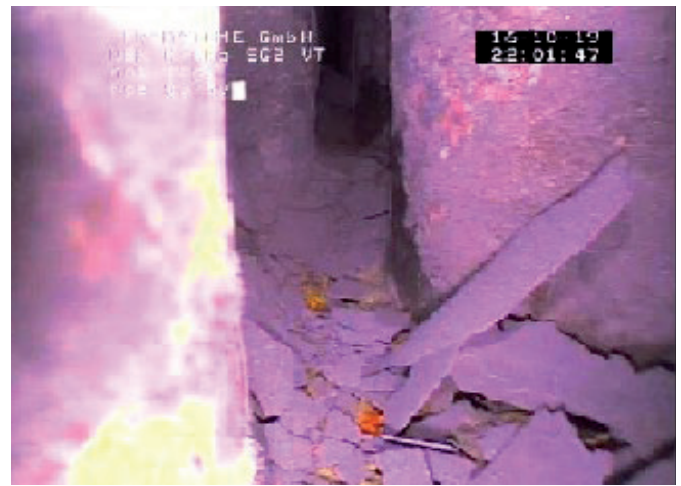
Fig. 11: Fallen scales of magnetite after SG drying phase

Before the final VT (visual inspection) of the tube sheet, where foreign bodies were registered and the size of the area with hard sludge was determined, the plan was to dry the tube bundle with hot air as in previous outages. As a result of drying, peeling of a thin layer of hard scales on the tubes occurred. This is probably due to a combination of chemical cleaning and later hot air drying, which led to an uneven expansion of the scaling material and tubes of the steam generator (Figure 5). The result was a large amount of magnetite "scales" that were washed into the BD system and not taken into account in the final mass balance of removed sludge.

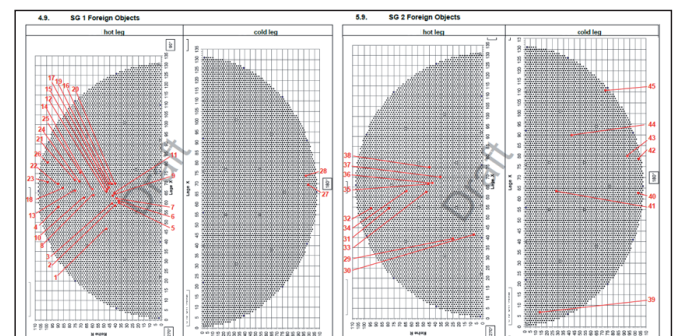
Fig. 12: Foreign object placement after outage 2019

Chemical cleaning was used to dissolve the hard sludge at the top of the tube sheet, which also revealed some foreign objects that were in deeper layers and had never been discovered before. The number of foreign objects is high, but most of them are thin wires that probably belonged to a wire brush.

Due to their weight and size the discovered foreign object are non-dangerous (classification: Type 1 / Category 3; Foreign Object Classification), but they leave a bad impression and they will have to be monitored in the future. If the process of accumulation of hard sludge continues, it will "disappear" over time. Their removal is not necessary and would often be technically impossible or at least very complicated and time-consuming.

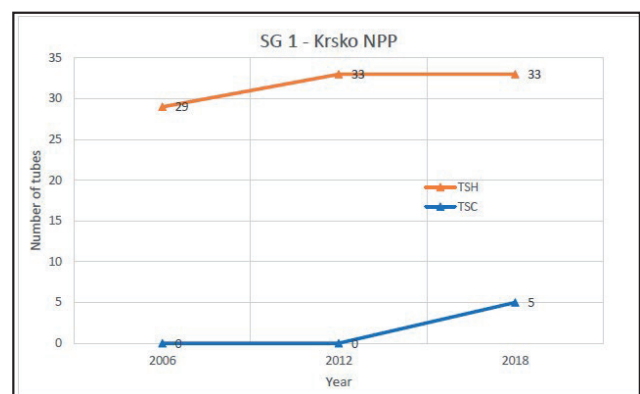
Fig. 14: Hard sludge area and DNT's after CC in SG #1 HL

ECT SG #1 in 2018 detected 33 dents on HL, which is essentially a small number based on the size of the "hard sludge" area. Interestingly, the 2006 denting mechanism was more developed at SG #1 (29) than at SG #2 (12). Nevertheless, the increment of a new dent at 6 cycles (2006-2012) was lower at SG#1. The right picture of the tube sheet shows the remaining "hard sludge" area after the 2019 chemical cleaning. The 2018 dent population has remained trapped in this area, which is not good. Optimistic about SG #1, however, is the fact that we only have 33 dents and that there were no new ones from 2012 to 2018. Since almost all dents remained in the hard sludge area, we have to say that chemical cleaning on SG #1 HL did not fulfill expectations.

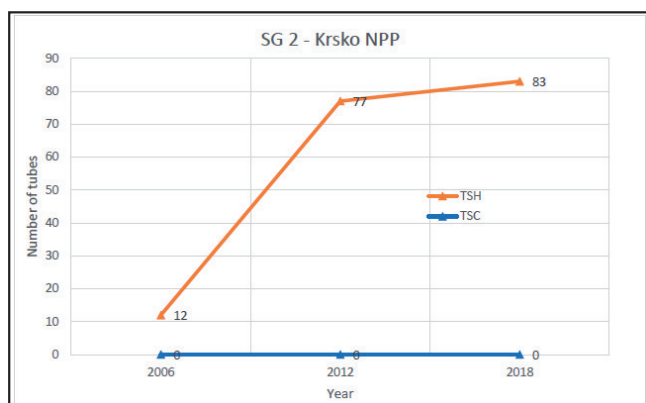
Fig.16: Hard sludge area and DNT's after CC in SG #2 HL

ECT SG#2 in 2018 detected 83 dents on HL, 2.5 times higher than SG #1, although the hard sludge areas were comparable in size. The denting mechanism started slower than at SG #1, and its result is higher than at SG#1. Chemical cleaning was much more successful at SG #2 because it cleaned > 70% of the area in which the 2018 dents are located. This is far more important because the number of dents at SG #2 is much higher (83) as per SG #1 (33). It is here that we expect that the degradation mechanism will not develop further.
