HRVOJE GLAVAŠ¹

Infrared Thermography in Maintenance of Building Applied Photovoltaics

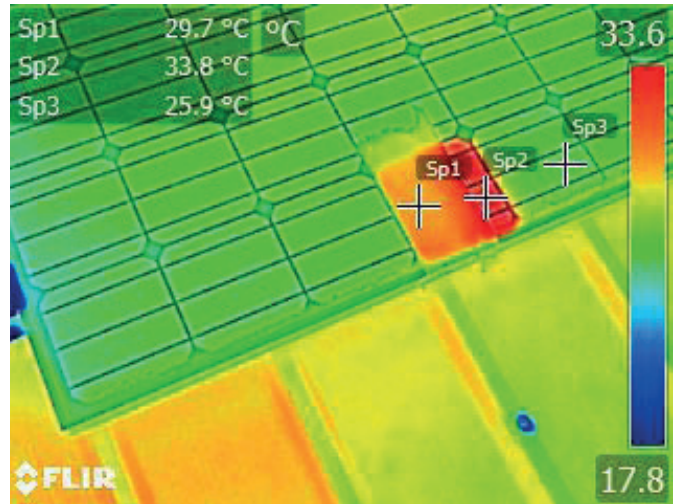
Figure 7. The thermographic pattern of the panel cell

The example of shade cell in Figure 6, does not generate electromotive force and represents resistance to the flow of current from the other cells of the series, resulting with heat dissipation shown in Figure 7. The analysis was made with the FLIR E6 infrared thermal camera resolution of 160 x 120 pixels, 45 ° x 34 ° field of view, operating temperature range from -20 °C to 250 °C, noise equivalent temperature difference or NETD <0.06 °C, refresh rate of 9 Hz and accuracy of ± 2 % or 2 °C of reading, with a set emissivity of ε = 0.85 characteristics for glass. Despite the high emissivity of glass, the problem of reflection of IR radiation is not negligible, as indicated in the paper [7].

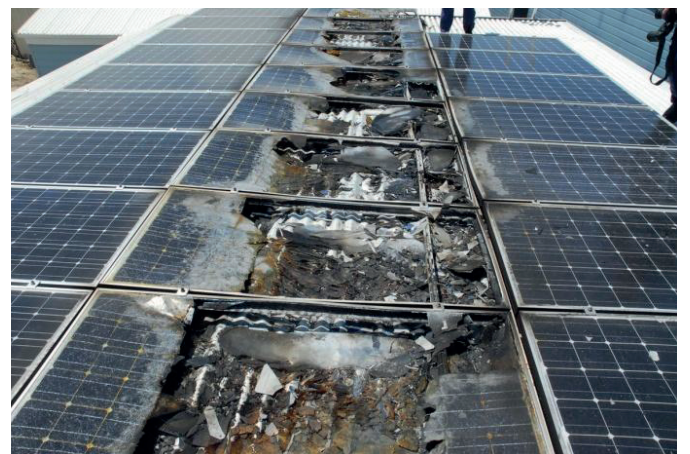
Monitoring the condition of the equipment is indispensable because defective equipment can lead to significant negative consequences. Figures 13 and 14 show the consequences of the defective PV system.

Figure 13. The consequence of fire on photovoltaic system, example [9]
