Cable Aging Management Program Implementation in Krško NPP-NEK

Marko Pirc

NEK d.o.o.

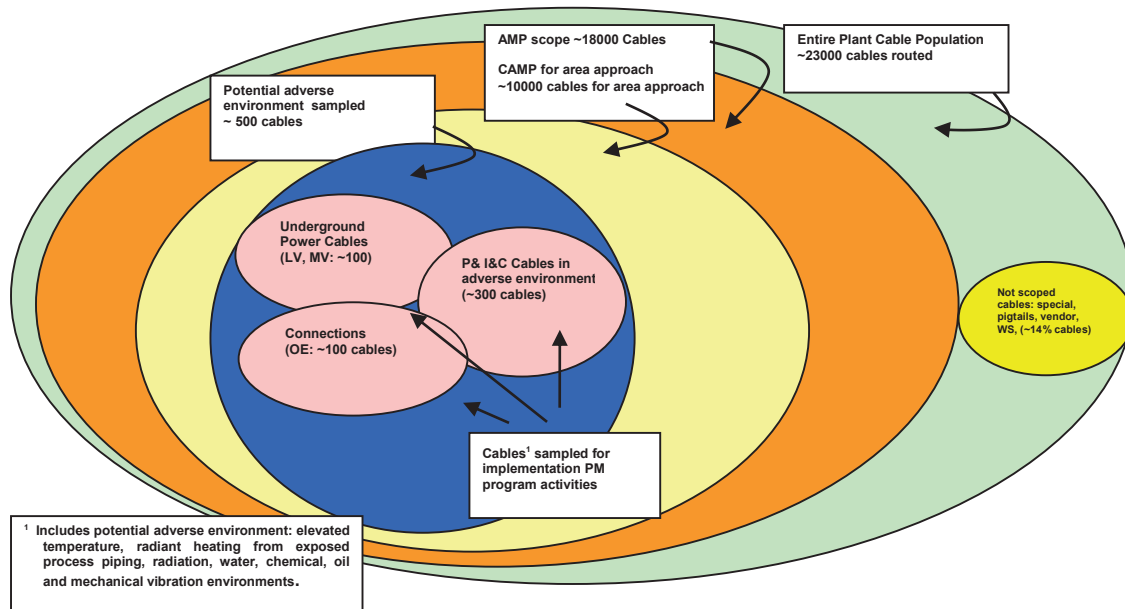
Figure 1: Cable scoping and sampling process [1]

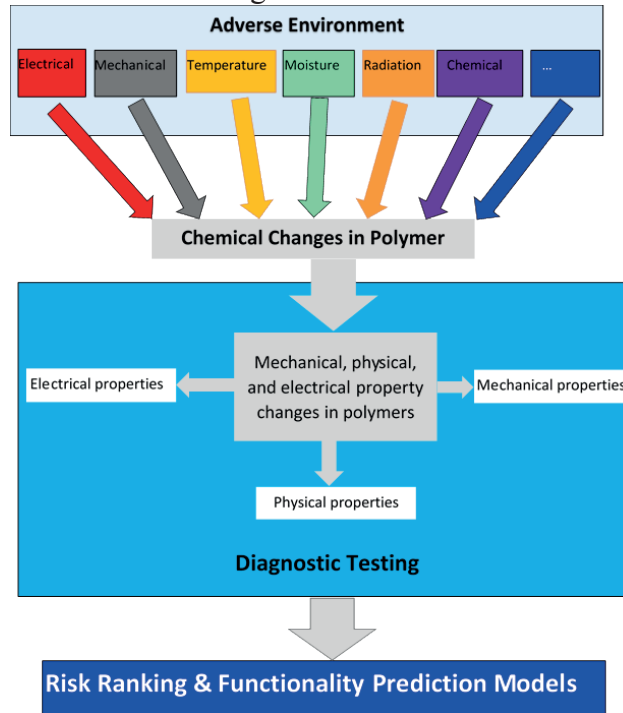
In the first phase, at aerial approach focus is to determine adverse environment parameters with visual inspection and environment monitors to find hot spots and deficiencies.

In second phase, onsite diagnostic testing methods are used with acceptance criteria to evaluate basic electrical and mechanical properties to check functionality and risk ranking of cables.

In the third phase, aged samples are taken for laboratory test to determine the actual scale of different properties change. Laboratories testing are used for detailed remaining life prediction.

Figure 3: Cable Aging Detection and Remaining Life Prediction [4]

appropriate action based on risk ranking model or remaining life prediction. Overview of concept is shown on Figure 3.

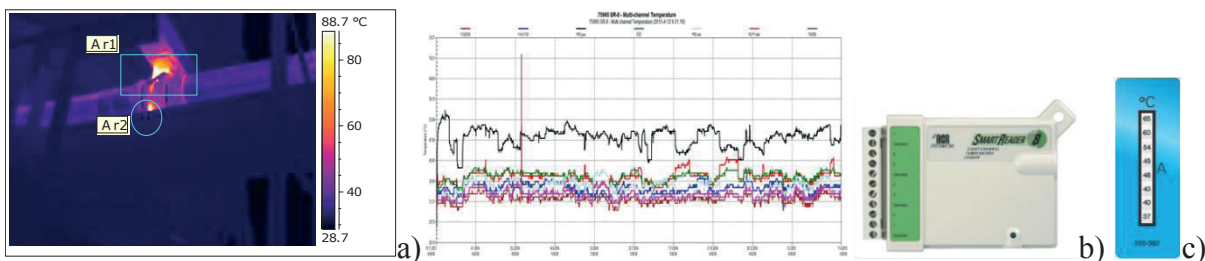
Appropriate tools for local temperature harsh environment finding are Infrared Camera, Data logger and Memory sticker for one time use showed with some results in Figure 4.

Figure 4: Different temperature monitors: a) IR camera, b) data logger, c) irreversible label [9]

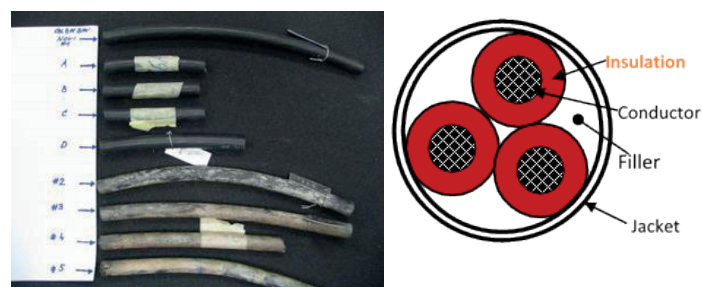
Criteria was developed on 21 samples of cables from warehouse and aged in oven at 120°C for 9 different time stages and results shown on Figure 6 [6]:

- Sample #1 new cable: from 10 to 13 N/mm NEW
- Sample #A (72 h) and #B (144 h): 10-13 N/mm OK
- Sample #C (240 h) and #D (360 h): 11-17 N/mm and 14-20 N/mm TRENDING
- Sample #2 (528 h): 85-118N/mm and #3 (1032 h): 151-206 /mm End of Life (EOL)-Replace
- Sample #4 (1872 h): 170-250N/mm and #5 (3264 h): 227-283N/mm EOL- Replace

Samples are used for training for visual inspection and acceptance criterial development for IM of different materials. For jacket material CSPE (in all SR cables) three stages: up to 15 N/mm NEW material; from 16-80 N/mm initial degradation of jacket, insulation OK; 3 year – TRENDING; more than 80 N/mm End Of Life reached: Replace Cable Jacket hardened and can crack; insulation possible damaged.

Figure 6: Samples of 9 stages Owen Aged Control Cable (BIW 7C#14 AWG) [6] and description of jacket and insulation

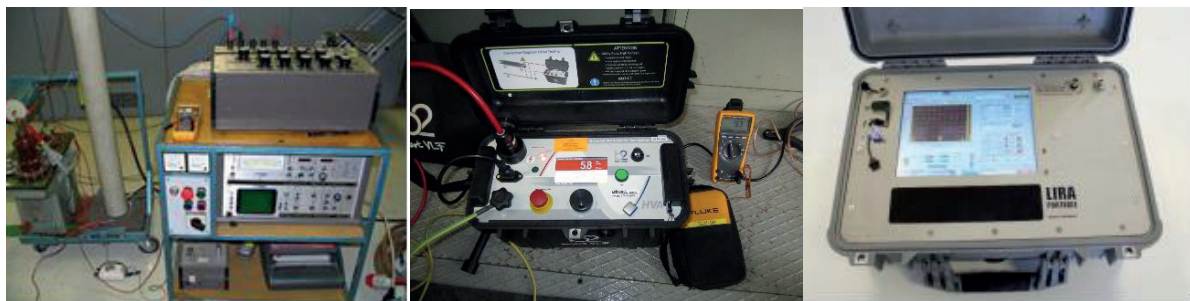
Figure 7: a) $\tan \delta$ testing equipment with 50Hz and b) 0,1Hz and c) LIRA

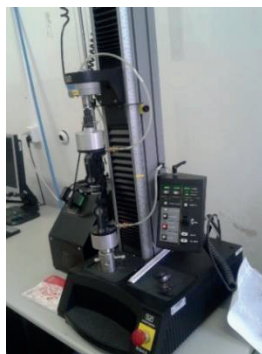
- **Elongation At Break (EaB):** is the ratio between changed length and initial length after breakage of the test specimen. The elongation at break defined by the EN ISO 527 standardized method for tensile mechanical properties of the polymer, used for End of Life (EoL) prediction, with known and predefined acceptance criteria for different materials (i.e. 300% for new cable and 50% for EoL). Testing equipment is presented on Figure 8.

Figure 8: Testing equipment for EaB

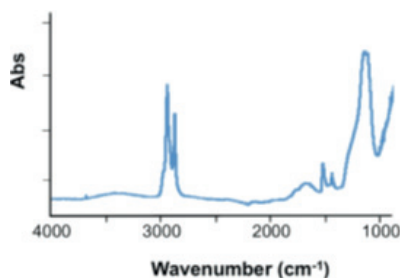
- **FTIR Fourier Transform Infrared Spectroscopy:** Oxidation and crosslinking of cable insulation polymers such as EPR and XLPE inherently introduce new chemical bonds within the material, including C=O carbonyl and C=C carbon bonds that have unique vibrational frequencies. A convenient method, therefore, for characterization of related polymer degradation is FTIR spectroscopy. An example FTIR spectrum of EPR is provided in Figure 9.

Figure 9: FTIR Spectrum for EPR [3]

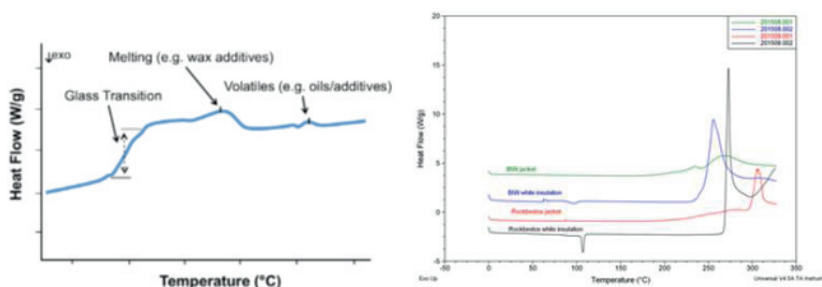
- **DSC Differential Scanning Calorimetry** Differential scanning calorimetry (DSC) is a technique that is especially useful for characterization of semi-crystalline polymer systems. DSC measures the flow of heat in and out of test samples over time as a function of sample temperature. Features in a DSC curve include phase change transitions. As illustrated in the DSC curve of EPDM and Oxidation Induction Time (OIT) in Figure 10, heat flows into a sample with rising temperature to effect endothermic transitions including transition from solid to a glassy state, the glass transition, and from a glassy solid to a melted liquid. Heat is also consumed in the evaporation of volatile compounds such as added processing aids. In a semi-crystalline polymer, it is the material in the crystalline regions that undergoes a distinct melting transition. The integral of the melting peak in the DSC curve is thus a direct measure of the crystalline content of the system. The shape of the DSC curve, including the location of glass transition, is also related to chain scission and cross-linking that the polymer may have experienced.

Figure 10: Description of DSC Curve of EPDM Showing Glass Transition, Melting Point and Evaporation of Processing Additives [3], [9]

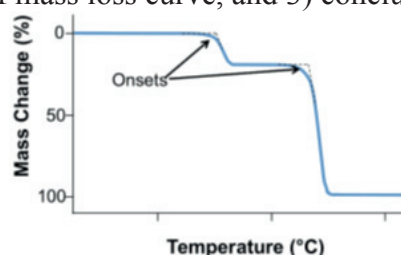
- **TGA - Thermogravimetric Analysis** – In thermogravimetric analysis (TGA), the mass of a sample is monitored as a function of temperature and time. The experiment may be performed under inert, reactive, or oxidizing atmosphere and the TGA may be combined with a mass spectrometer to detect mass fragments of species volatilized during sample heating. Mass loss with heating can reveal copolymer ratio, moisture content, volatile additive content, and inorganic filler content. The decomposition behaviour of polymer samples at higher temperatures can also reveal information regarding the extent of chain scission and cross-linking in the polymer. Thermal decomposition in the TGA experiment may be a useful measure of relative degradation and history of polymer samples. The thermogram curve in Figure 11 illustrates transitions with 1) onsets of mass loss of distinct constituents, 2) inflections of mass loss curve, and 3) conclusion of mass loss.

Figure 11: Illustrative TGA Showing Mass Loss due to Decomposition of Distinct Components [1]

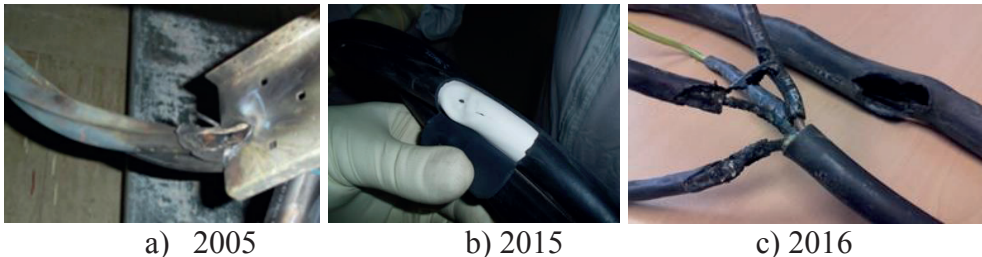
- Insulation resistance (IR) or Megger test as standardized test is not giving very useful results finding mainly severely damaged, failed cables: 3 LV power cables failure found due mechanical damage in tray (all triplex power cables without jacket) shown on Figure 12 and one N1E underground failure c), in splice .

Figure 12: Failures due of LV power cables found with IR test

- LIRA 8 testing done 8 findings and deviations: 3 on field cables and 5 at beginning LIRA instrument testing with known location of cable damage (short circuit, bad connection, cut in insulation, local burned insulation). In figure 18 Spot Signature (dB) is shown with LV cable failure at two locations. Short circuit on Figure 12 was found on 30m from cable end (at load) is visible as left marked pick on Figure 18 b) and c).

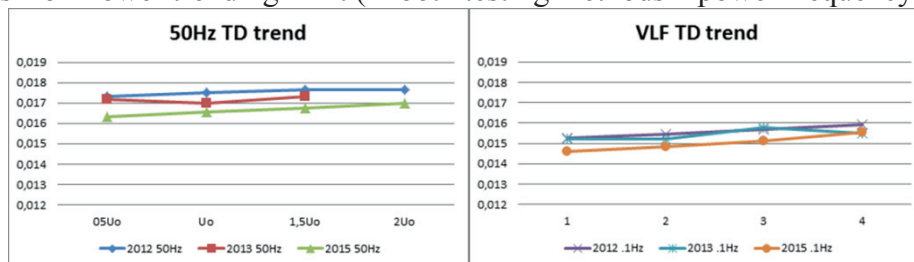
- 55 MV cables were tested with 5 findings in trending criteria for $\tan \delta$ results (all with accessories – connections and splices). The only qualified cable trending results for last three tests conducted in 2012, 2013 and 2015 on Figure 13 does not show significant changes from lower trending limit (in both testing methods – power frequency and VLF).

Figure 13: Trending results for $\tan \delta$

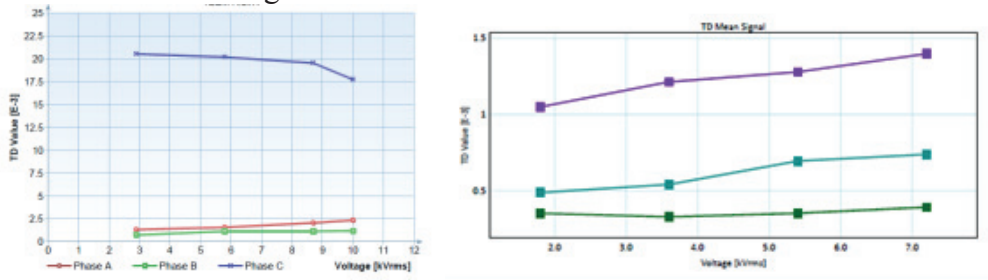
- MV cable N1E with XLPE insulation and splice improved trending results significantly after corrections in field Figure 14.

Figure 14: $\tan \delta$ results for XLPE after corrections

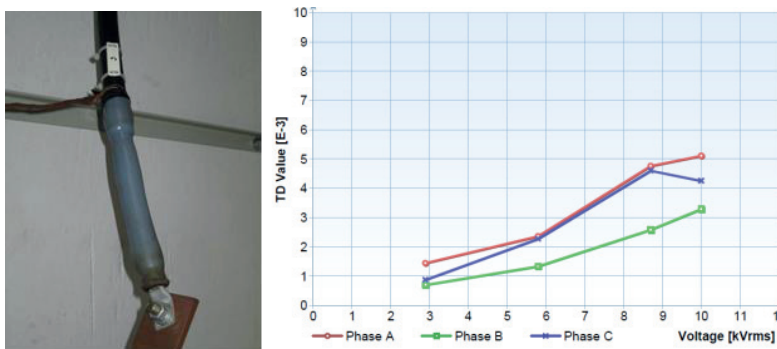
- MV cable N1E with XLPE insulation found bad connection

Figure 15: Found deficiency on XLPE cable connection with diagnostic test

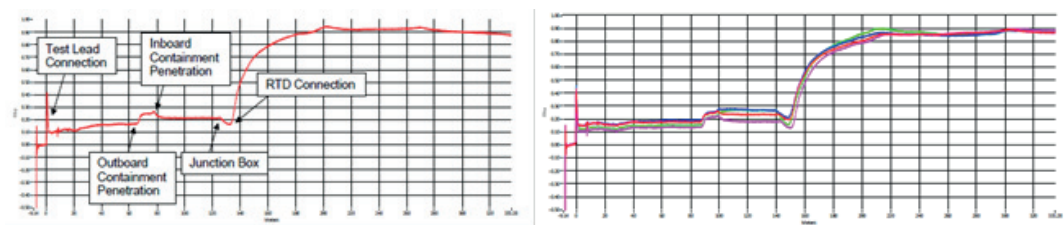
- TDR results of RTD cables after modification on Figure 16

Figure 16: TDR test plot for comparison
