**University of Zagreb Faculty of Electrical Engineering
and Computing**

ANALYSIS OF SURGE ARRESTERS FAILURES IN THE INSTALLATION OF BROADCASTING TRANSMITTER

SUMMARY

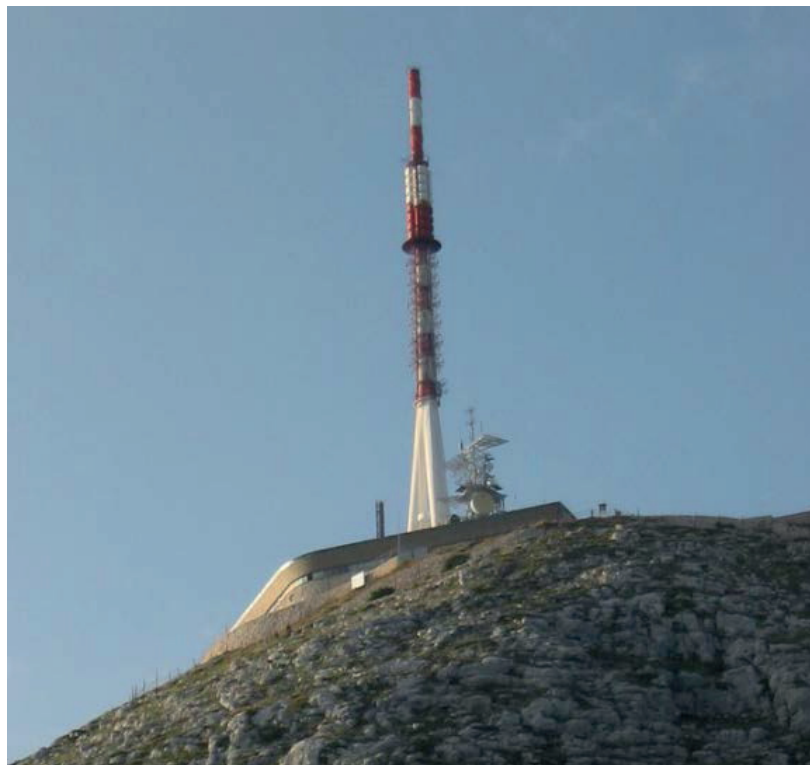
In the operation of the BT, located at 1762 m above sea level, Figure 1, during a lightning storm, comes to frequent SA failures in the switchgear of BT, Figure 2 and along the 10 kV supply cable (SAs in the cable section boxes). BT is power supplied from 35/10 kV transformer substation using 10 kV cable line length 8.455 km. The cable is sectioned by four cable boxes (CB1, CB2, CB3 and CB6), Figure 3. In every CB are installed 2 disconnectors and 3 SA (one in phase). The SAs in CBs are $U_C=14$ kV, line discharge class 4.

Figure 1. BT on Biokovo maintain 1762 m above sea level

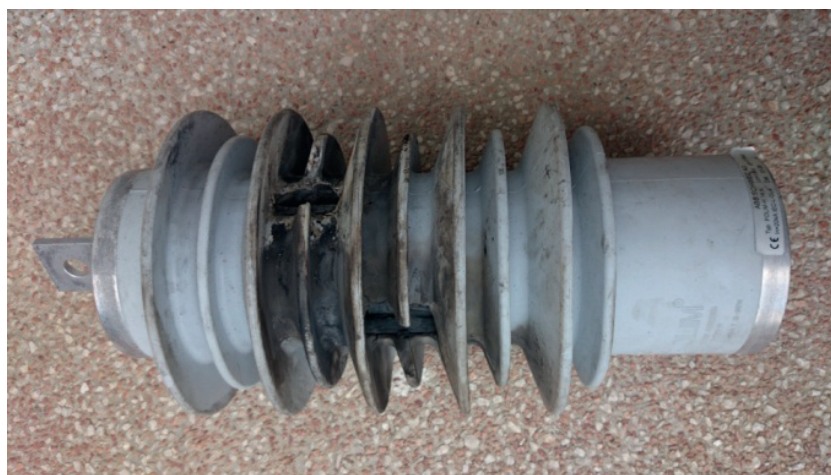
Figure 2. Overloaded SA

SA failures have occurred in the switchgear of BT and in the cable boxes CB6 and CB3.

Failure of the SAs occurs by heating above the thermal stability limit. Therefore, if the SA is heated above the thermal stability limit, it leads to the thermal destruction of the SA and ultimately to earth fault (line-to-earth fault). Thermal destruction of SAs in the switchgear of BT occurs as a result of large number of lightning strokes in a very short time interval, table II. Every lightning stroke increases the temperature of MO resistors. There is not enough time for cooling of MO resistors between the lightning strokes or to return to a stable operating point. It leads to overheating and thermal destruction of the SA.

1. Reduction of earth electrode resistance of the BT, what increases the part of the lightning current flowing through the earth electrode and decreases the part of the lightning current flowing through the SAs. This solution requires considerable financial costs. It includes the rehabilitation of the earth electrode of the BT, replacement of existing and laying new earth rods in adequately prepared channels.

2. Increase the thermal energy absorption capability of SAs (several SAs of the same type in parallel). One set of 3 SAs are installed directly at the power

transformer and the second set of 3 SAs at the point of arrival of 10 kV cable to the BT. These SAs are approximately in parallel, in phases. For this application SAs must be selected and tested in the factory accordingly to verify equal current distribution among them. For example, if the protective characteristics of parallel connected SAs differ only 1% one SA will absorb 64.45 kJ and other one 68.77 kJ (in one scenario of lightning stroke). Therefore, the protective characteristics of SA must be different under 1% in order to ensure equal current distribution in two parallel connected SAs.

3. Increase the cooling of SA (avoid squeezed closed spaces as places for installation).

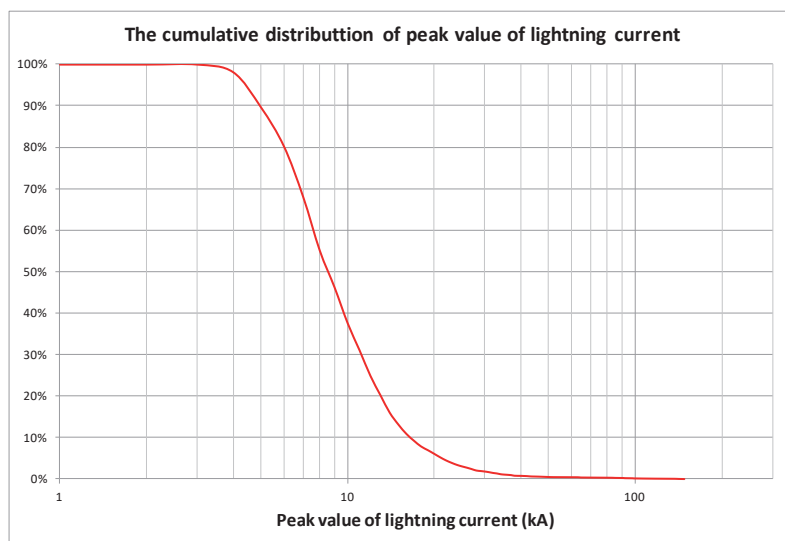
Figure 4. The cumulative distribution of peak value of lightning current (3939 lightning strokes) [2]

From Figure 4 can be read that 37.6% of all lightning strokes have a peak value greater than 10 kA. Less than 10% of lightning strokes have a peak value greater than 17 kA, and the peak value of lightning strokes greater than 37 kA, is less than 1%. The maximum peak value of lightning strokes (148.9 kA) was measured on 19th December 2011. This statistical analysis shows that the peak value of lightning strokes significantly deviating from those stated in Table A.1 in the IEC 62305-1 [6].

In accordance to Figure 4 lightning strokes with so large peak value of current are unlikely.

Lightning current 37 kA, 10/350 μ s is simulated next, because less than 1% of peak value of lightning strokes are greater than 37 kA according to Figure 4. The absorbed energy of SAs in the switchgear of BT are calculated, Table VII. Different values of absorbed energy in phases occur due to different values of the power-frequency voltage at the time of stroke. From Table VII it is clear that the energy overload of SAs in case of one lightning stroke is unlikely. Therefore, the energy overload of SAs is due to lightning flash with more than one lightning stroke or more lightning flashes in short time.

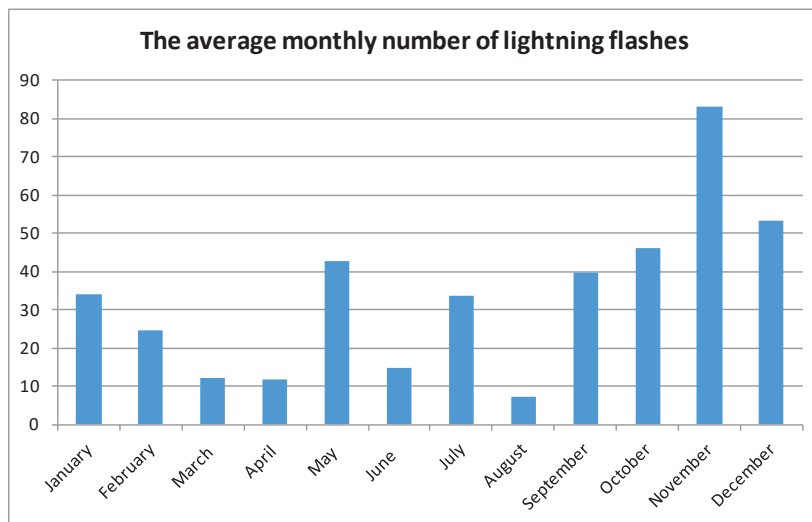
Figure 7. The average monthly number of lightning flashes

Analysis of lightning strokes by months is following. Lightning strokes were collected inside 2 km radius around the BT using LLS [2]. Figure 7 shows the average monthly number of lightning flashes calculated using an average multiplicity 1.63. Lightning strokes were collected in the period January 2009 until January 2015. It can be concluded that the greatest number of lightning flashes in the BT were in October, November, December and May, Figure 7. Accordingly, the largest number of SAs failures was in those months.

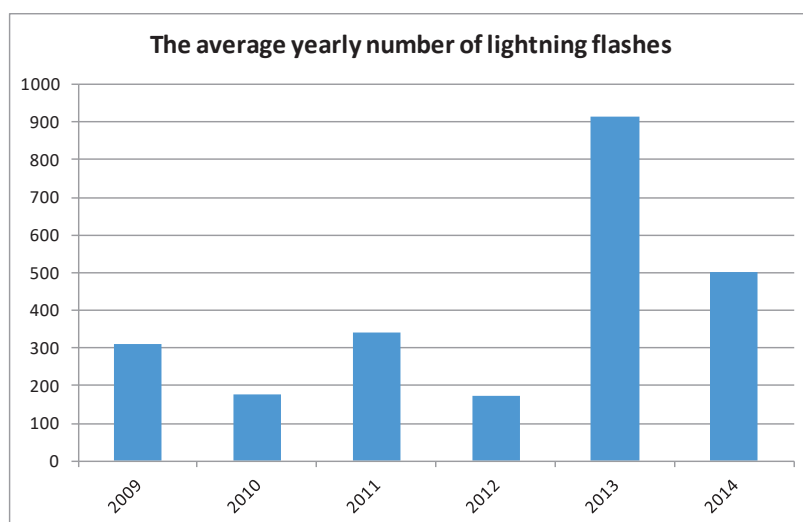
Figure 8. The average yearly number of lightning flashes

The average yearly number of lightning flashes inside 2 km radius around the BT is shown on Figure 8. It is clear that the number of lightning flashes varies considerably from year to year, and that 2013 was an extreme year by lightning flashes at the location of the BT.

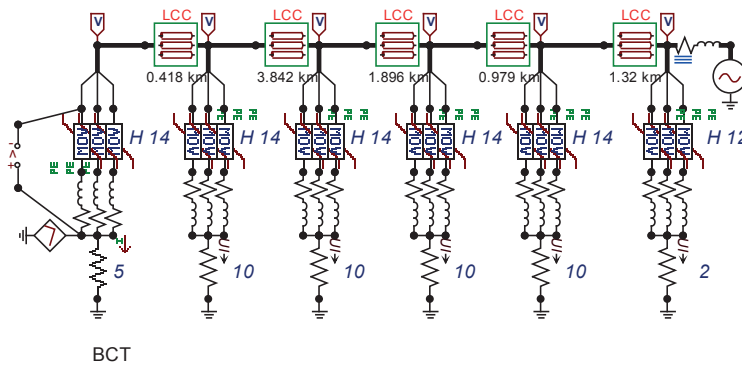
Figure 10. ATPDraw model

ATPDraw [8] simple model, shown in Figure 10, is formed for simulation of lightning stroke in the BT. Lightning stroke is simulated as the injected current. SAs of continuous operating voltage $U_C = 14$ kV and $U_C = 12$ kV, line discharge class 4, are modeled with their protective characteristics, Table III. SA can absorb about 186 kJ ($U_C = 14$ kV) and about 160 kJ ($U_C = 12$ kV). The connections of SAs to the earth electrodes are modeled as $R=1$ m Ω and $L= 1$ μ H (or $L= 2$ μ H in dependence of their length). MV cables are modeled using JMarti model and electrical and geometrical parameters of the cable. Earth electrode resistances of the BT and of the CBs are not known. They had been measured but the sheath and the armor of the cables had not been disconnected. Because of that, resistances of certain earth electrode are not known. The assumption is that the earth electrode resistances of each one CB is 10 Ω and the earth electrode resistances of the BT is considered as parameter: 5 Ω , 10 Ω and 20 Ω . The earth electrode resistance of the BT is not necessary to modeled as nonlinear [9] according to equation (1) because the limiting current to initiate sufficient soli ionization, equation (2), in given case are: 159.16 kA ($R=20$ Ω), 636.6 kA ($R=10$ Ω) i 2546.5 kA ($R=5$ Ω).

The lightning current 200 kA, 10/350 μ s is simulated according to [6] and the absorbed energy of SAs in all three phases are calculated. Obtained values are in Table IV (for SAs in BT), Table V (for SAs in CB6) and Table VI (for SAs in CB3). SA with $U_C = 14$ kV, line discharge class 4, can absorb about 186 kJ, as previously was told. It is clear that energy-overload of all three SAs (in the switchgear of BT) will occur for any value of earth electrode resistance in the range (5-20) Ω . Energy-overload of all three SAs (in CB6) will occur for value of earth electrode resistance in range just above 5 Ω . Such case of failure of all three SAs in the switchgear of BT has not been occurred.
