ANALIZA PODEŠENJA DISTANTNE ZAŠTITE PROVEDBOM PRIMARNIH POKUSA ANALYSIS OF DISTANCE PROTECTION SETTING BY PERFORMING PRIMARY TRIALS

U radu su opisani pripremni radovi i sama provedba primarnih pokusa na T-spoju 110 kV-og voda TE Plomin – TS Šijana – TS Vincent.

The work describes the preparatory work and the very performance of primary trials at the T-junction of the 110 kV transmission line of Plomin thermal power plant – Šijana substation – Vincent substation.

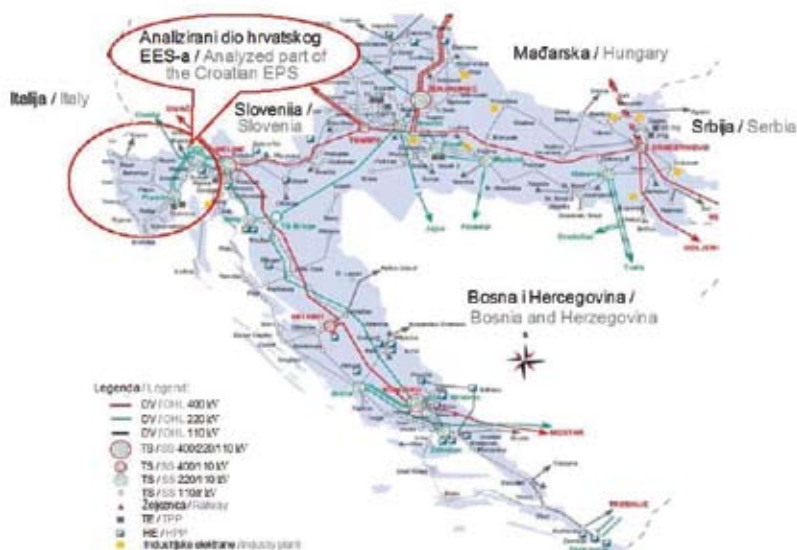
Slika 1 — Hrvatski elektroenergetski sustav
Figure 1 — The electrical power system of the Republic of Croatia

Hrvatski prijenosni elektroenergetski sustav podijeljen je u četiri područja (slika 1). Zapadni dio sustava koji se razmatra u radu sastoji se od vodova 220 kV i 110 kV. Dvije termoelektrane smještene na istočnom dijelu poluotoka Istre jedina su dva snažna čvorišta u tom dijelu EES-a.

The Croatian transmission electrical power system is divided into four zones (Figure 1). The western part of the system analysed in the work consists of the transmission lines 220 kV and 110 kV. Two thermal power plants located in the eastern part of the Istrian peninsula are the only two powerful hubs in that part of the electrical power system.

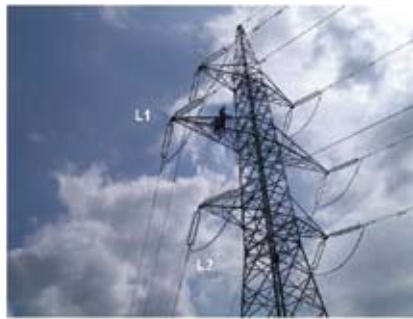
Slika 10 — Raspored vodiča na 49-om stupu
Figure 10 — Arrangement of the conductors on the 49th tower

After the change of the parameters in the communication system, the performance of primary trials was initiated. Primary trials were performed on tower number 49 on the extension from the Plomin thermal power plant to the hub point (49,46 %, 16,234 km). Because of the arrangement of the conductors on the tower, Figure 10, tests L1-E and L1-L2 were performed.

Before the performance of the tests the power line was out of operation, the copper wire with the intersection of 1 m^2 was attached to L2 phase and detached from the power line by isolation tape. After that the transmission line is switched on, the isolation tape is cut and the wire falls on the tower console and this causes a short circuit between L1-E.

The preparation for the two-pole fault was performed in the same manner, but the wire was attached to L1 phase and the cutting of the isolation tape fell onto L2 phase which caused the fault (L1-L2).

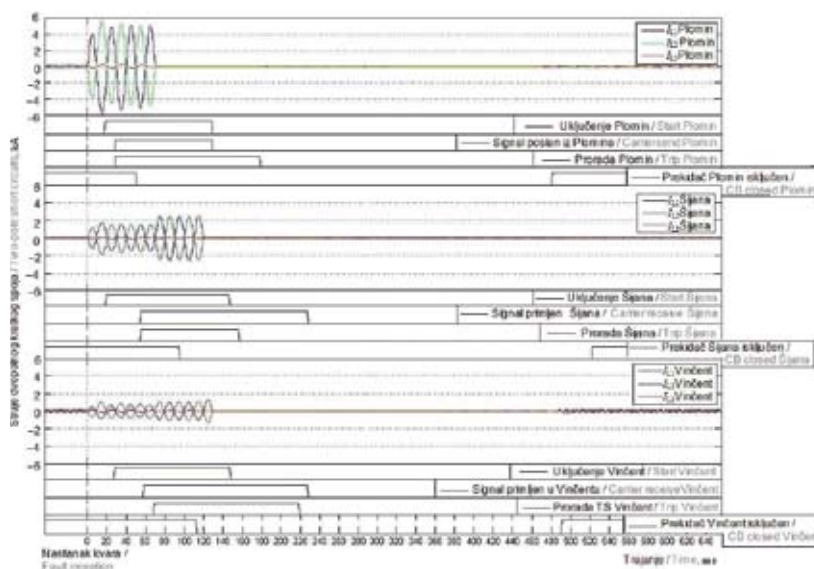
Slika 12 — Analogne i digitalne vrijednosti za vrijeme ispitivanja kod dvopolnog kratkog spoja (L1-L2)

Figure 12 — Analogous and digital values for the duration of the trial at a two-pole short circuit (L1-L2)

Based on the records from the numerical relays, Figure 12 shows analogous values and digital signals recorded during the L1-L2. Figure 13 shows the ignition of the arch during the fault.

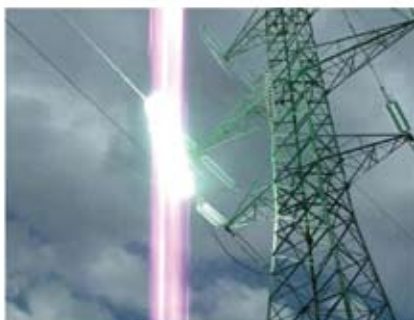
Slika 12 — Luk za vrijeme dvopolnog kratkog spoja (L1-L2) za vrijeme ispitivanja

Figure 12 — The arch during the two-pole short circuit (L1-L2) during the trial
