Danijel Brezak  
Končar - Electrical Engineering Institute Inc.  
[dbrezak@koncar-institut.hr](mailto:dbrezak@koncar-institut.hr)

Dalibor Filipović-Grčić  
Končar - Electrical Engineering Institute Inc.  
[d Filipovic@koncar-institut.hr](mailto:d Filipovic@koncar-institut.hr)

## ULTRASONIC METHOD FOR TESTING OF POWER TRANSFORMERS

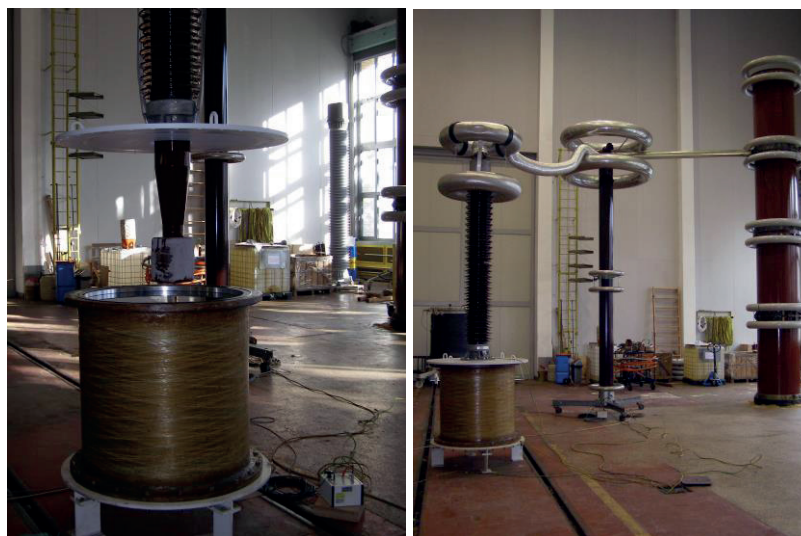
**Figure 11. Screen electrode test setup**

Therefore a laboratory test was initiated. A test setup was assembled to produce the same electric field strength as in-service (figure 11). Several end shields were tested using an electric method and ultrasonic method simultaneously.

Four sensors were placed at the bottom of the test tank. One of the end shields (screen 1, figure 12) showed high PD-s but with very low acoustic activity. This activity is within the range of surrounding noise of an on-site test.
