Ivan Šulc  
Končar - Electrical Engineering Institute Inc.  
[isulc@koncar-institut.hr](mailto:isulc@koncar-institut.hr)

## AN ASPECT OF TRANSFORMER INRUSH CURRENT

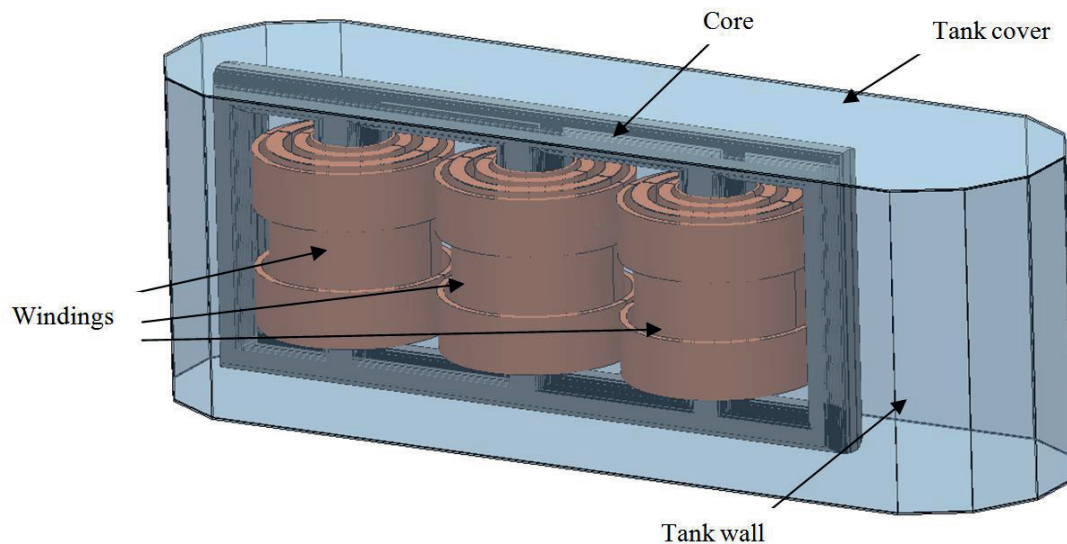
**Figure 3 – 3D transformer model used in analysis**

Considered three-phase 3/2 transformer model includes three basic parts; winding, core and tank (Figure 3). Tank is divided into two parts: the cover and the wall. These two parts are electrically connected only by a copper connection (jumper) and by another "test jumper" with a variable DC resistance. In order to approximate saturated conditions in the core, relative core permeability is substantially reduced to values equal or less than  $\mu_r=100$ . Winding currents are given with their rated values. Model is solved in time-harmonic (quasi-stationary) sinusoidal domain in order to avoid computationally expensive time "step-by-step" (transient) calculation method.

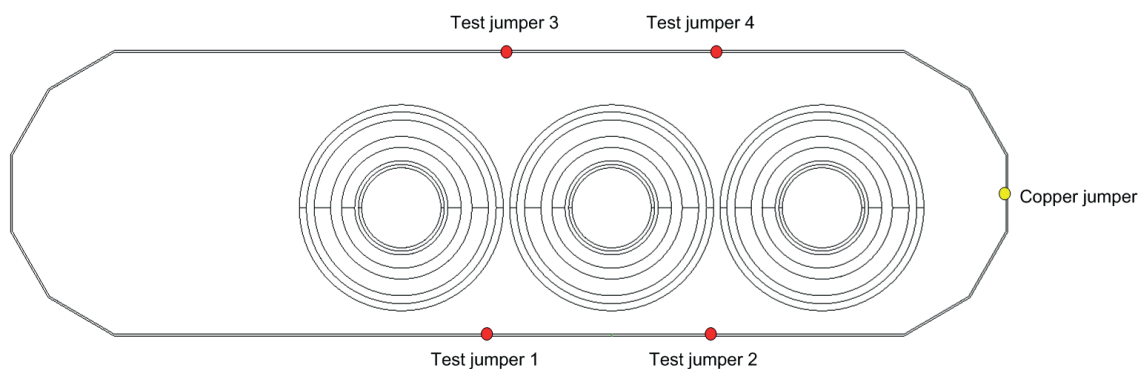
**Figure 4 – Positions of test jumpers and copper jumper**

Test jumpers are placed at four different positions connecting the tank wall and cover. DC resistance of test jumpers is changed in order to observe values of currents passing through the jumper and evaluate voltage between the wall and cover at various positions. In the meantime the copper jumper has a fixed position as shown in Figure 4.
