# ANALIZA VELIKOG KVARA U TRAFOSTANICI NA OTOKU KRETI

## THE STUDY OF A MAJOR 2008 SUBSTATION INCIDENT IN THE EPS OF CRETE

Emmanuel Thalassinakis – Thales M. Papazoglou, Iraklio, Crete,  
Greece

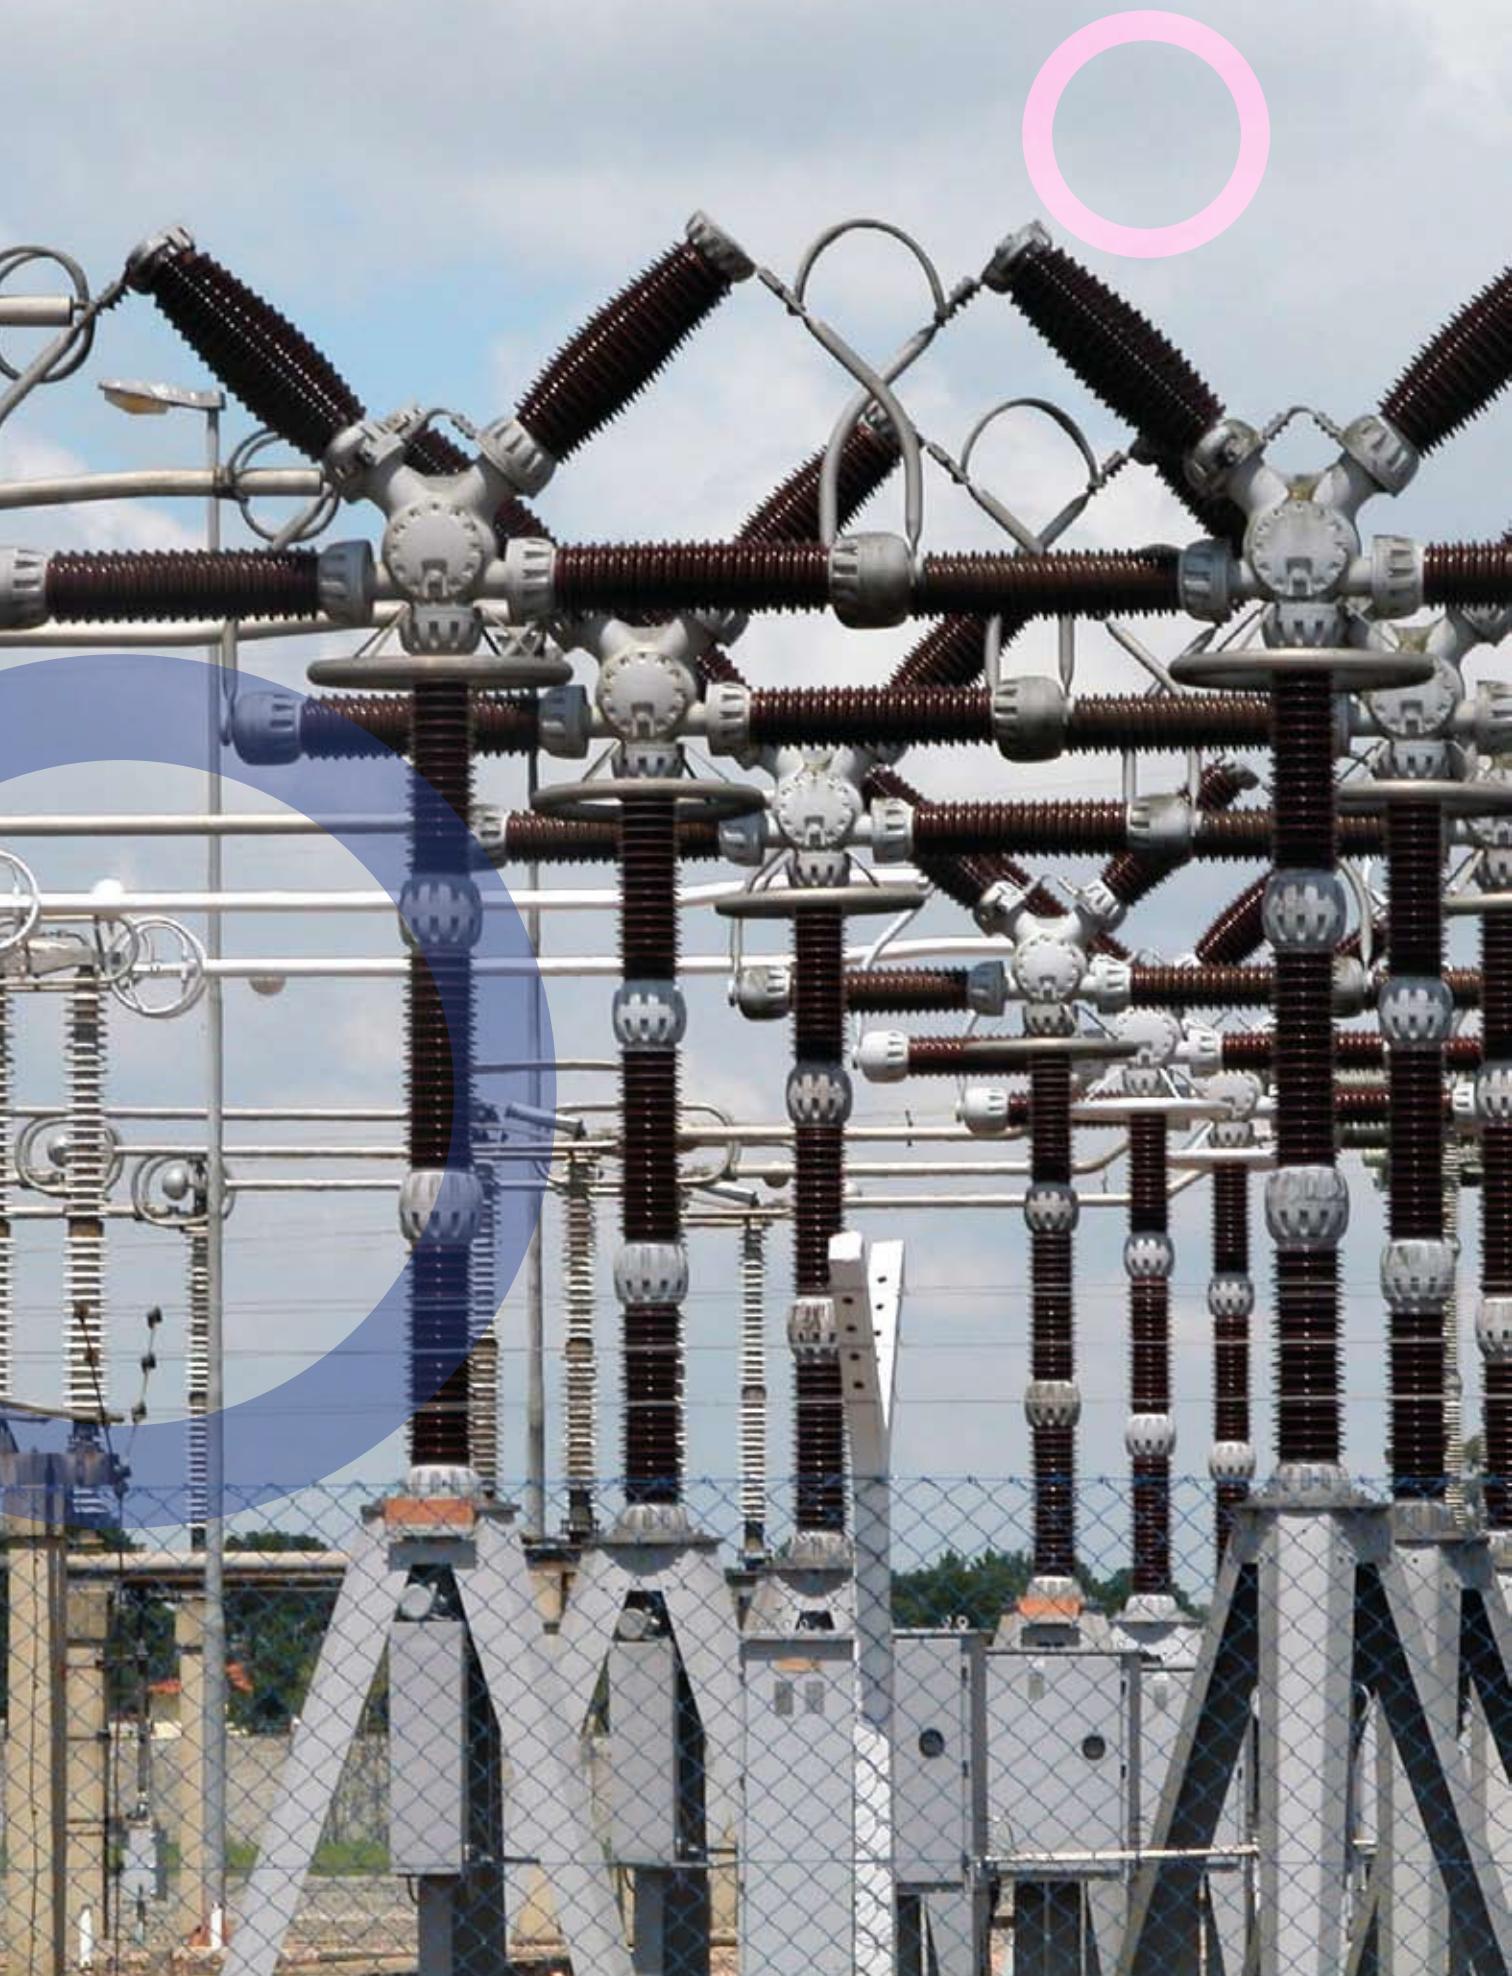
From the post-mortem on-site investigation it became apparent that the fault began as a single-phase MV cable fault connecting the secondary of the first transformer of SS Iraklio 3, just 5 m away from the point of the subterranean entrance of the cable. It was a high resistance fault that is known not to energize the transformer differential protection. Due to the heat produced by this fault, the LV cables of the capacitor node-protection, which were in the vicinity, had their insulations burnt, and therefore the MV was transmitted to the capacitor bay causing complete destruction due to heat and fire. In addition the MV had been transmitted to all the protection and control circuits of the substation.

Shortly afterwards, the fault developed into a three-phase fault causing the differential transformer protection to open the circuit breaker P215 (Figure 1) on the transformer secondary side, but, it failed to open the breaker P15 (same figure) due to the destruction of the corresponding trip-circuit. In other words, the fault failed to be cleared. The fault currents have been estimated to 4 933 A. These currents were sustained for 16 continuous minutes, producing destructive heat that resulted in extensive fires in the substation installations. The end result was that Power Transformer # 1 of the substation suffered extensive damage, as had all the control and protection equipment, including one internal service transformer, three audio-frequency transformers, etc. which were destroyed.

Following this experience, it is considered a must to separate the power cables from the control and protection cables passing them through completely different channels. Moreover, back-up transformer protections are advisable. For example, there should be a back-up protection in case differential protection fails to act. So, a high-current protection should be enacted, at a slightly higher time-interval, at the HV breaker of the transformer. In addition, a restricted earth-fault protection could be necessary, which is more sensitive to single-phase faults.
