Corrosion Detection and Surface Repair with Coatings on Condensate Storage Tanks Internal Surfaces

Matija Guliš, Sanja Smirić, Lenart Pušnik

Keywords — Corrosion, Condensate Tank, NDE, Coating, Aging Management

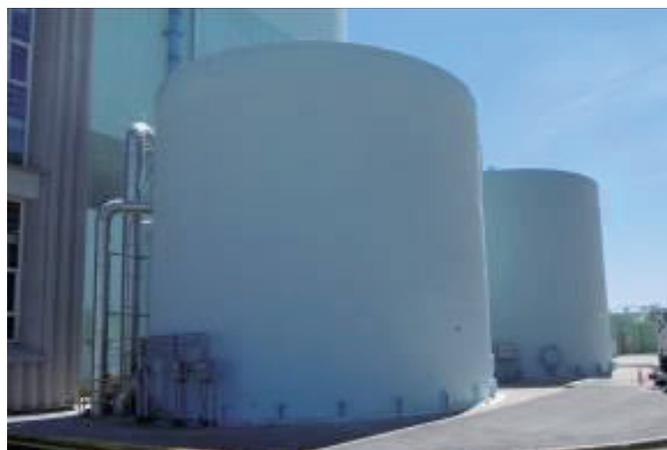
Fig. 1. Condensate storage tanks 1 and 2

In the Nuclear power plant Krško, there are two single hull condensate storage tanks with floating diaphragms each containing up to 757 m³ of demineralized water. They are designated as CY101TNK-001 and CY101TNK-002 respectively (Fig-

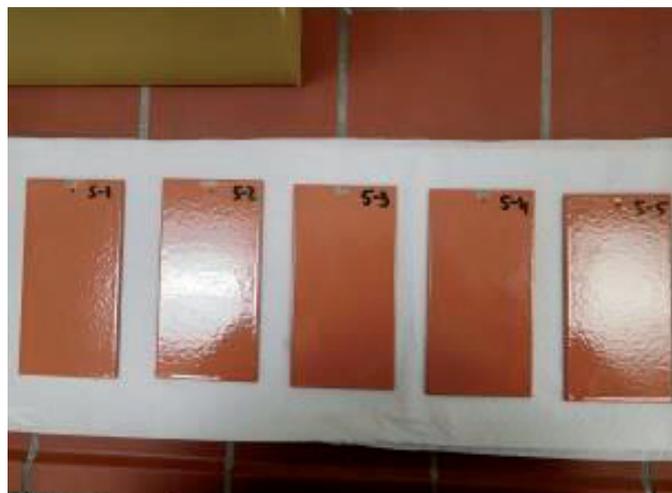
Fig. 7. Test coupons Hempel

For the purpose of testing materials all proposed/selected coating materials were applied on test coupons (carbon steel, dimensions 150 \times 75 \times 2.5 mm, 5 test coupons/system) in accordance with ASTM D5139 Standard Specification for Sample Preparation for Qualification Testing of Coatings to be Used in Nuclear Power Plants [10] (see Figure 7 and 8). Before material application, all coupons received surface preparation to grade Sa 2.5 according to ISO 8501-1.

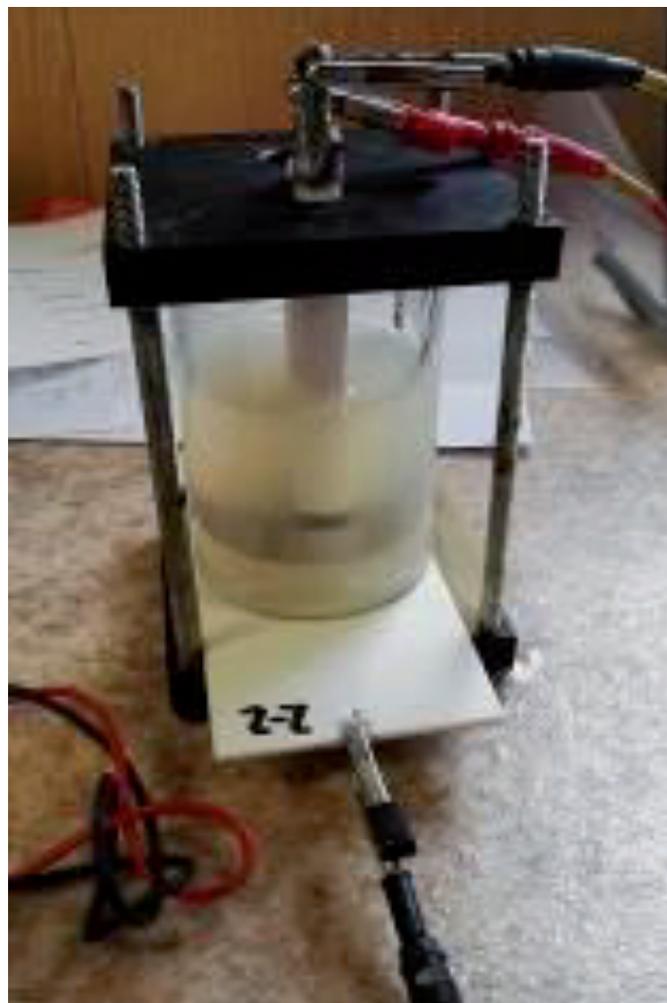
Fig. 9. Impedance measurement

Before immersion tests a final drying of coating on test coupons was accomplished at room temperature for a period at least of 3 days. Afterwards test coupons were visually examined due to local defects (in accordance with ISO 4628-1 to 5), the dry film thickness was measured, also the adhesion measurement was performed (pre and after immersion tests; in accordance with ASTM D4541 “pull-off test”) and finally EIS (Electrochemical Impedance Spectroscopy) was determined (ISO 16773-1 to 4; requirement: no porosity – before/after immersion, Figure 9).

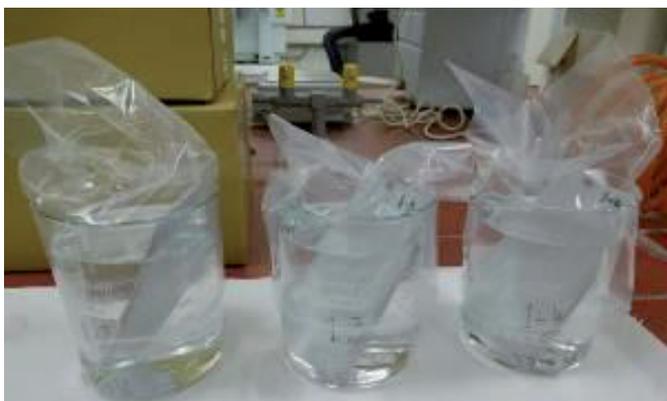
Fig. 10. Test coupons in immersion

Immersion tests (according to NACE TM 0174, procedure B [8]) lasted for 14 days and were performed in NEK chemical laboratory. Three (3) test coupons/coating systems were immersed in pure water (Q water) at a volume of 900 mL (Figure 10).

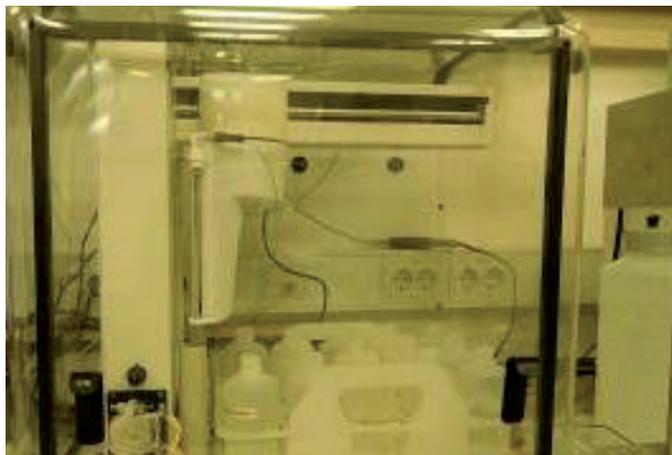
Fig. 11. Samples of working fluid in NEK laboratory

Samples of working fluid (water medium) were analyzed in the NEK chemical laboratory (Figure 11) to determine the presence of released anions (sulphates, chlorides, fluorides, acetates and formates – in accordance with procedure CAP-6.552, Določevanje anionov z ionskim kromatografom ICS 3000, [11]) inside specified values defined in ADP-I.6.02I, Kemijske specifikacije in kriteriji za korektivno ukrepanje [7]. Samples were analyzed before the beginning of immersion tests, after 7 days and at the end of immersion (14 days period).
