Mechanical and 1st Chemical Cleaning of NEK Steam Generators

Robert Kelavić, Marko Turalija

Summary — Sludge removal is performed on two steam generators (SG's) at the Krško Nuclear Power Plant (NEK) during every outage. SG's are a meeting point of five major plant systems: Reactor Coolant System (RC) on the primary side and four systems on the secondary side – Auxiliary Feedwater System (AF), Blowdown System (BD), Main Feedwater System (FW), and Main Steam System (MS). Sludge removal activities take place on the secondary side of the SG's on the top of the tube sheet. It always consists of classical Sludge Lancing (SL) which is done by spraying water at different angles (30°, 90°, 150°) between the tube gaps in the steam generator tube bundle with a pressure of around 220 bars. Another method is Inner Bundle Lancing (IBL) which means spraying water directly inside the tube bundle with a traveling lance tape with a spraying nozzle at the end. Water is sprayed at an angle or directly on the top of the tube sheet with a robot-guided manipulator which is placed inside a steam generator. The manipulator and therefore the spraying action is controlled by an operator and at times it is

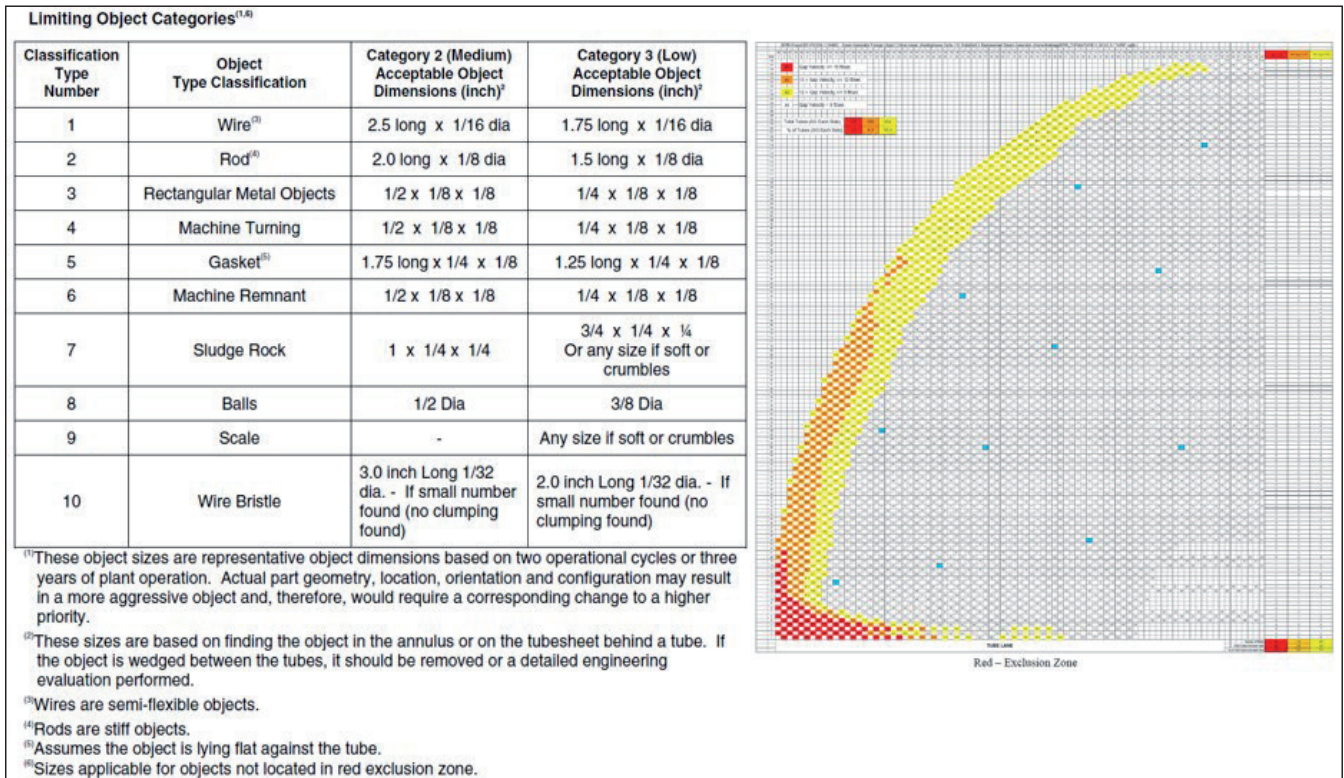
Fig. 13: Classification of foreign objects and the area of high hydrodynamic flow at the periphery of the SG tube bundle - EPRI summary SGMP TR 1020989

If a foreign object is found inside the SG, its location is carefully noted, the object is categorized, its length, weight and material is approximated. The categorization is carried out using the EPRI Technical Report 1020989 Steam Generator Management Program: Foreign Object Prioritization Strategy for Triangular Pitch Steam Generators. Based on the shape, size, and position of the object, its general location inside the SG, and some other factors, a decision will be made if a retrieval attempt is performed. TV crawler in that case acts as a guide for the operator who manually inserts the tool and tries to grab the object stuck inside the SG. The success rate of these attempts varies and depends mostly on the skill of the operator of the FOSAR tool and experience. If an object is retrieved, a detailed analysis is conducted to determine its origin and structure. If the attempt fails, the location is reported and ECT inspection of the contact and surrounding tubes is performed at the shortest possible interval. Some objects are monitored during the entire time of operations in the SG's.
