BOJAN FRANC IVO UGLEŠIĆ

University of Zagreb Faculty of Electrical Engineering and Computing

Croatian Transmission System Operator Ltd.

LIGHTNING DATA UTILIZATION IN POWER SYSTEM CONTROL

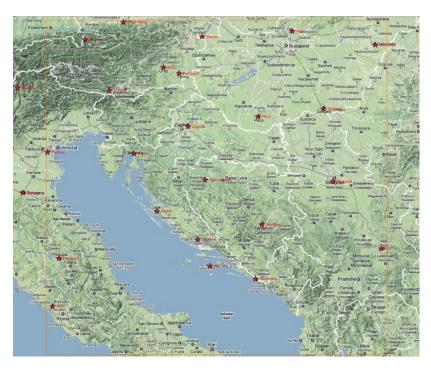
Figure 1. LINET sensors in Croatia and its neighboring countries with monitored area

At the end of 2008, a lightning location system was constructed, covering a wide area of the Croatian territory as part of the LINET network. Six sensors have been installed in Croatia (Zagreb, Rijeka, Nin, Sinj, Dubrovnik, island Korčula). LINET is a modern lightning location system with a network of more than 125 sensors covering most of Europe. LINET sensors utilize VLF/LF frequency ranges and detect magnetic flux at the moment of an atmospheric discharge [6]. Figure 1 shows LINET sensors in Croatia and its neighboring countries [7].

Lightning data gathered by lightning sensors are sent unprocessed through the Internet to the processing center, where data is processed and formatted. Formatted data is subsequently available for download to subscribed clients. Lightning data are taken from the processing center and stored in a local database. Data is available for the period beginning January 1, 2009. The monitored area is shown in Figure 1.

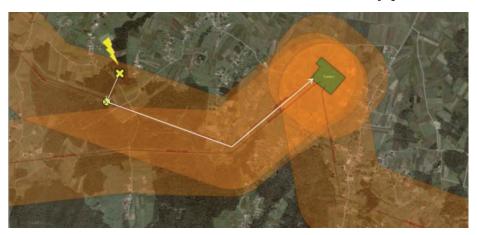
Figure 2. Spatial correlation of lightning stroke with overhead line alarm zones

For GIS input, a communication interface is available. GIS data contain geometries (points, lines, polygons) of power system facilities (e.g. overhead lines, substations, power plants, etc.). This enables a real-time interconnection to an external GIS database, making it possible to import and synchronize GIS data directly in case of a change. Where an external GIS database is not available the system utilizes a web based tool for GIS data import and management. GIS data enable the spatial correlation between lightning data and geometries representing power system facilities. It also enables the calculation of the exact distance of a fault location caused by a lightning stroke to the nearest substation (Figure 2). This information can be correlated with data from the distant relay protection.

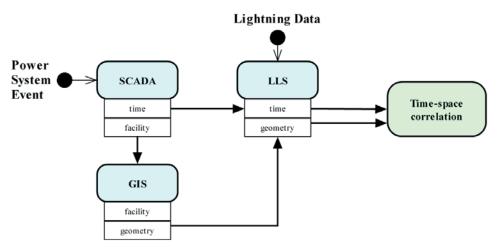
Figure 3. Time-space correlation schema

For the input of data referring to failures in the power system (e.g. power outages, automatic reclosures, circuit breaker operation, distant relay protection operation, etc.) in real time, the system specifies communication interfaces specific to individual needs and conditions. Data from remote systems (protection relays, station computers, etc.) obtained through SCADA can be fetched by implementing clients for DAIS Alarms & Events or OPC server. By specifying which protection equipment and which signal types are to be correlated with lightning strokes, it is possible to determinate events caused by lightning strokes in near real time and present the information to dispatchers accordingly (Figure 3).

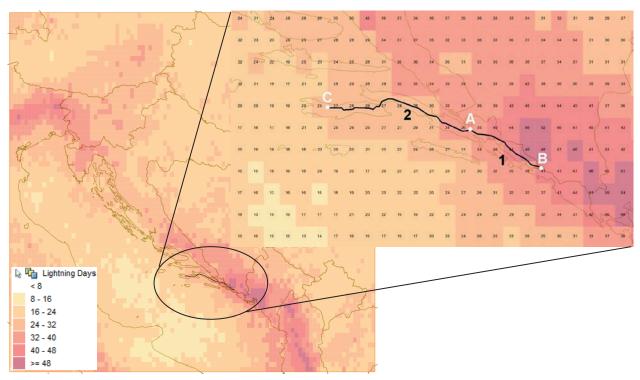
Figure 4. Map displaying isokeraunic map of lightning days (2009-2011) with monitored overhead lines (marked 1 and 2 on the map) and adjacent substation (marked A, B and C)

Two adjacent 110 kV overhead lines have been observed for faults and lightning activity in an area with heightened number of power outages. For calculation of lightning statistics, LLS data for the last three years (2009 – 2011) was available. Although a three-year period is too short to provide a creditable statistic; the obtained data show correspondence with other relevant sources and are sufficient to demonstrate the calculation principles. The LLS measured up to 48 lightning days per year (e.g. the isokeraunic map) for the area surrounding the overhead lines. Figure 4 shows the position of the monitored overhead lines and the isokeraunic map of lightning days for the observed area.

One of the observed events on a 110 kV overhead line (marked 1 in Figure 4) occurred on 29th July 2011 (Figure 10 and Table III). Distant protection relays in adjacent substations registered pick-ups at 06:35:12.763 and 06:35:12.769 local time. Pickups were registered on a single (top) phase of the overhead line. Commands to circuit breaker were issued and successful automatic reclosures procedures were executed on both sides of the overhead line. The LLS registered a lightning stroke in the overhead line alarm zone with peak amplitude of -18.7 kA at 06:35:12.754 local time. The lightning stroke precedes the registered pick-ups with a time difference of 9 and 15 ms. The fault locator measured the distance to the fault at 20.3 km / 24.1 km from the substations, where the LLS measured 18.4 km / 25.2 km.

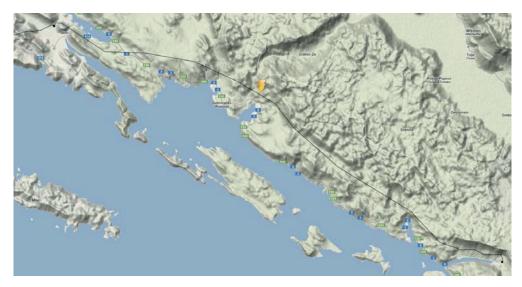
Figure 10. Lightning stroke causing line tripping Table III Correlated data

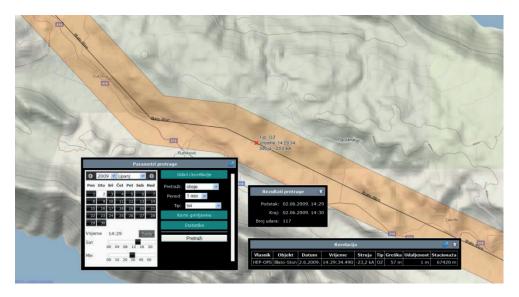
Figure 12 Time correlation between a lightning stroke and the relay pick-up

Figure 12 illustrates an example of the time correlation procedure by using the LLS. According to relay protection device data the fault which has occurred on 2nd June 2009 at the pick-up time of 14:29:34.521 caused the tripping of the line and its outage for 2 minutes. The fault occurred at a distance of 67.5 km according to the data of the fault locator function of the relay protection device of the respective overhead line. The LLS registered one lightning stroke which matches given criteria and which was possible to correlate with the observed relay protection fault detection. The correlated lightning stroke is of cloud-ground (CG) discharge type, stroke current amplitude of -23.3 kA, with a discharge occurrence time 14:29:34.490 and a distance of 67.429 km on the respective overhead line, with a location error of 57 m. Upon further analysis the time difference between the fault detection of the relay protection device and the lightning stroke recorded by LLS is 30 ms and the difference between the relay protection device fault location and the lightning strike location is 88 m, which is 0.1% of the total length of the observed overhead line.

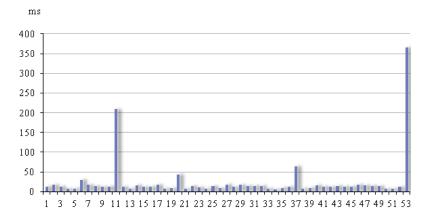
Figure 13 Correlated time differences between lightning strokes and relay pick-ups for 53 events

53 of the analyzed events matched the given criteria of the time difference and the time correlation between the lightning strokes and the protection device fault detection. The time differences between the lightning strokes recorded by LLS and the relay pick-up time for the 53 correlated and analyzed events (transmission line faults) are shown in Figure 13.

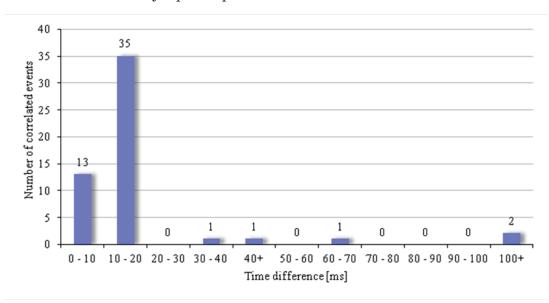
Figure 14 The distribution of correlated events according to time differences between the time of the lightning strokes and the relay protection device pick-up time

Figure 14 illustrates that the time differences vary between 6 ms up to 366 ms. Only three values are higher than 50 ms. The median time difference is 13 ms. The distribution of the correlated events according to time differences in the range

of 1-100 ms is illustrated in Figure 14. Figure 15 depicts more precise the time differences up to 30 ms. It can be seen that most of the correlated events have a time difference between 10 ms and 20 ms (Figure 14), with 48 of the 53 correlated events (91%) with time difference up to 18 ms. Results correspond to laboratory measurements of the relay's pick-up times discussed earlier.

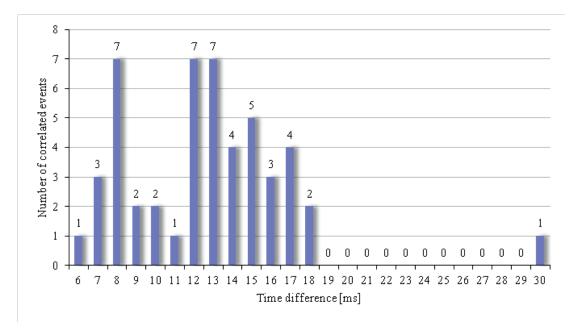
Figure 15 The distribution of correlated events according to the time differences between the lightning strokes and relay protection device pick-up time

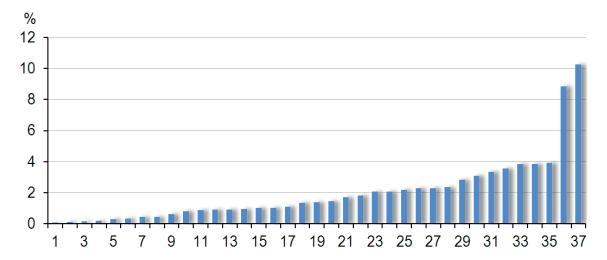
Figure 16 Differences between the lightning strokes locations determined by LLS and fault locations determined by the protection device

For 37 of the events for which the time correlation has been determined and the protection relay data of fault location were available, the difference between the lightning stroke locations determined by LLS and fault locations determined by the relay protection has been analyzed. The results of spatial correlation have revealed

the difference between the lightning stroke locations determined by LLS and the fault locations determined by the relays varies from 0.01% to 10.2% of total overhead line length, where the difference is between 1% and 2% for most of the correlated events, Figure 16. The average difference between the lightning stroke locations determined by LLS and fault locations determined by the relay protection device is 1.37% of total overhead line length.
