## **Experience of Tyco & Antamina in the Lightning Performance and Reliability Improvement of 220 kV Transmission Lines in Peru**

### **SUMMARY**

This paper presents details about the transmission line lightning performance studies and evaluation carried out by Tyco Electronics and Antamina in this partnership project. Methods to select the arresters characteristics and to define the quantity and the optimized arresters location along the lines are presented. Field experience obtained in these two first years and the line performance / reliability of the system after the TLA application in comparison with the performance before the arresters' installation are presented and discussed.

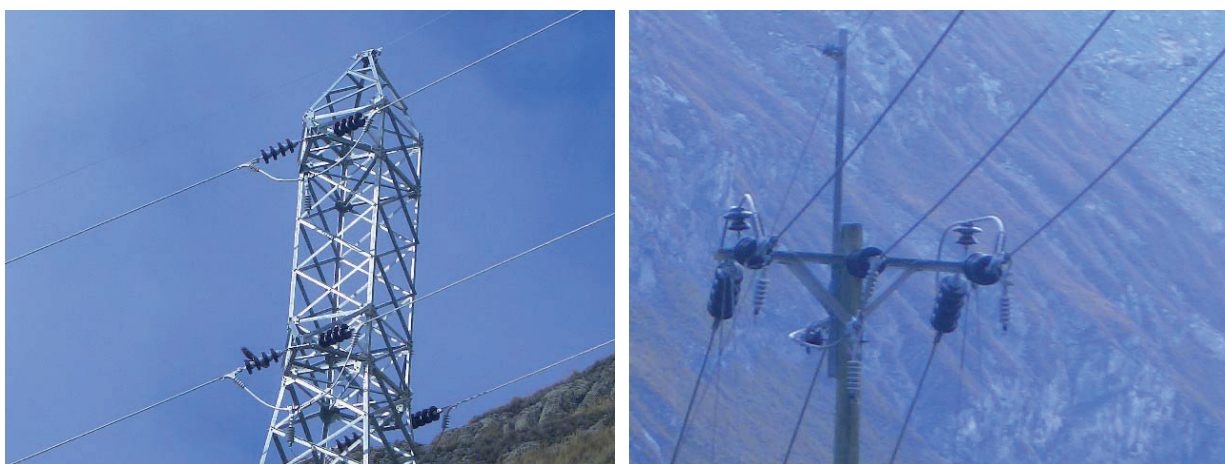
Figure 2 – Class 2 arresters installed on 23 kV overhead shielded distribution network

With basis in these studies, improvements were done in the earthing system of the line L-2255 and during the years of 2006 and 2007, approximately 450 units of class 2 gapless line arresters with rated voltage of 27 kV were installed along the 23 kV overhead shield distribution network. Figure 2 shows details of the line arresters installed on steel and wood structures for 23 kV.

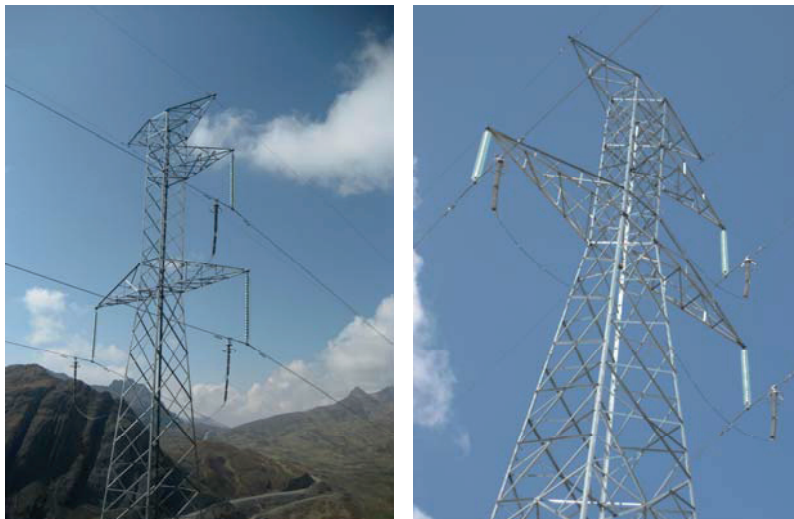
Figure 3 – Class 2 TLA with rated voltage of 192 kV installed along 220 kV line

The rated voltage of 192 kV was selected to TLA taking into account the maximum temporary overvoltages for the lines and their durations considering the systems effectively earthed. Maximum energy obtained in the studies was below 650 kJ to a discharge current of 100 kA and tower foot resistance of 150  $\Omega$ . It corresponds to class 2 arresters. Due to the installation in the altitude from 3,250 m to 4,800 m above the sea level, combined with the contamination and environmental

characteristics of the region, the TLA were selected with a minimum creepage distance of 9,765 mm. It means 25 mm / kV, taking into account the correction factor by the altitude. Lightning impulse withstand voltage for the TLA housing is 1050 kV, while the lightning impulse protective level of TLA is 510 kV. It corresponds to a factor 1.29 between the lightning impulse withstand voltage of the housing (taking into account the correction factor due to the altitude) and the TLA protective level.
