Improvement of the transmission and sub-transmission overhead lines lightning performance using line arresters – Experience in Brazil

Jorge Luiz De Franco – Franco Engenharia / Tyco Electronics - Brasil
José Pissolato Filho – Universidade Estadual de Campinas - Brazil

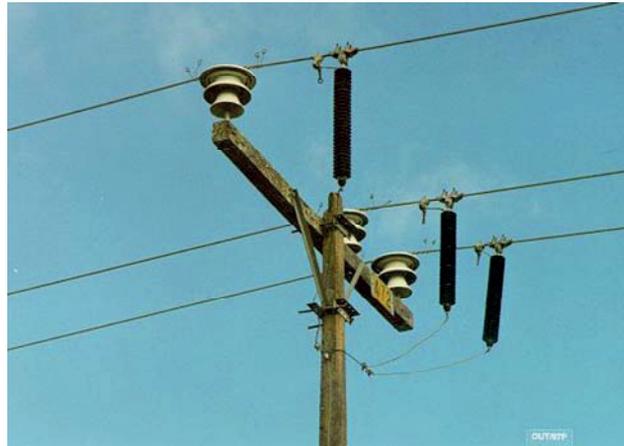
Figure 2 – Line arresters installed on 34.5 kV line – CEMIG [1]

Approximately 70% of all the gapless line arresters installed in Brazil are in the area under concession of CEMIG, located at Minas Gerais State. Besides CEMIG, FURNAS, Ampla, Light, CFLCL, UTEJF, Escelsa, RGE, CEEE, Porto Primavera Transmissora de Energia – PPTE and one industrial consumer - CVRD have been already installed or acquired line arresters to install along their 34.5 kV to 220 kV overhead lines. Details of the line arresters installed are shown in Figures 2 to 4.

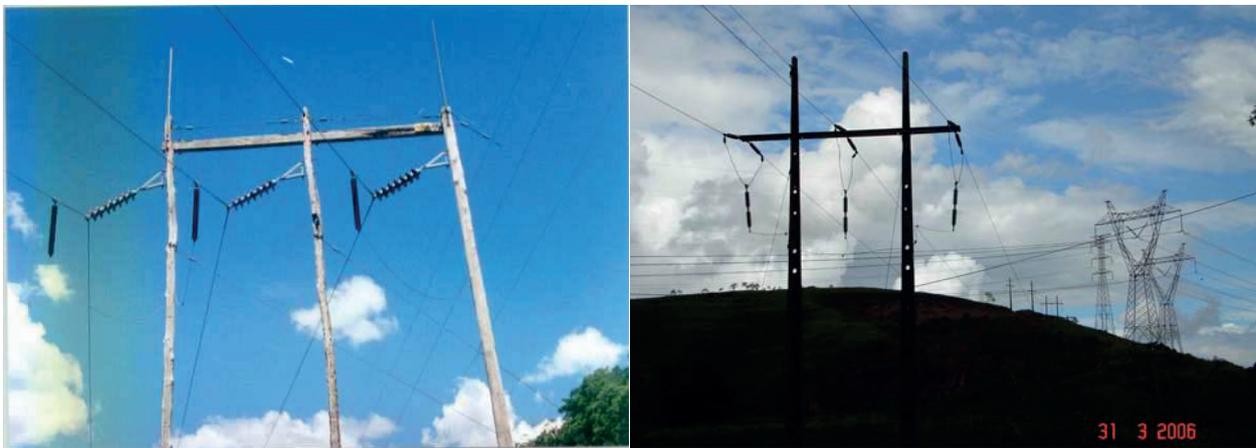
Figure 3 – Line arresters installed on 69 kV lines: Left CEMIG / Right Ampla

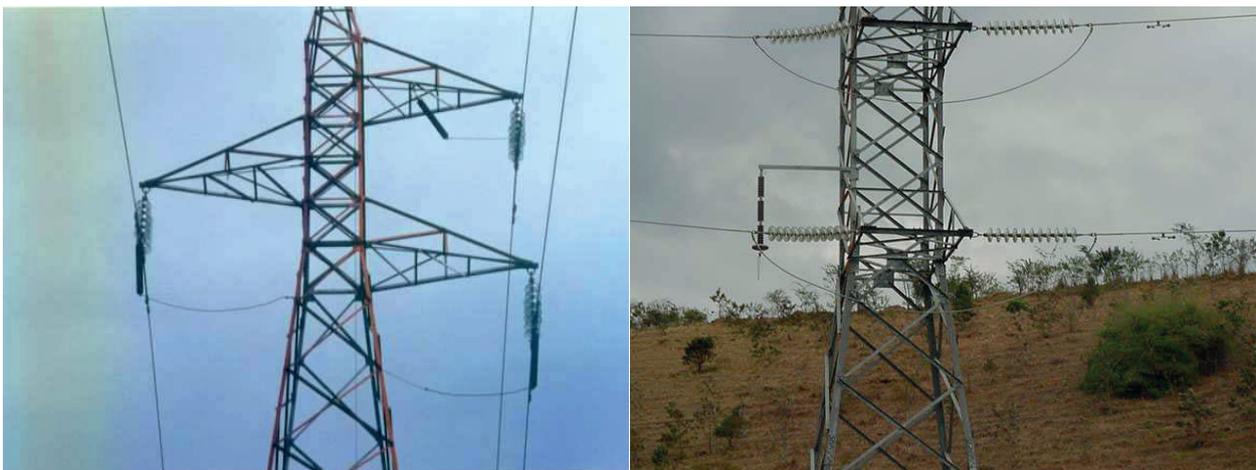
Figure 4 – Line arresters installed on 138 kV lines: Left – CEMIG / Right - UTEJF
